SUBJECT John Anglin, Clarence Anglin and
Frank Lee Morris Escape from Alcatraz

FILE NUMBER 76-26295

VOLUME NUMBER Enclosures 76, 137, 155 and 179

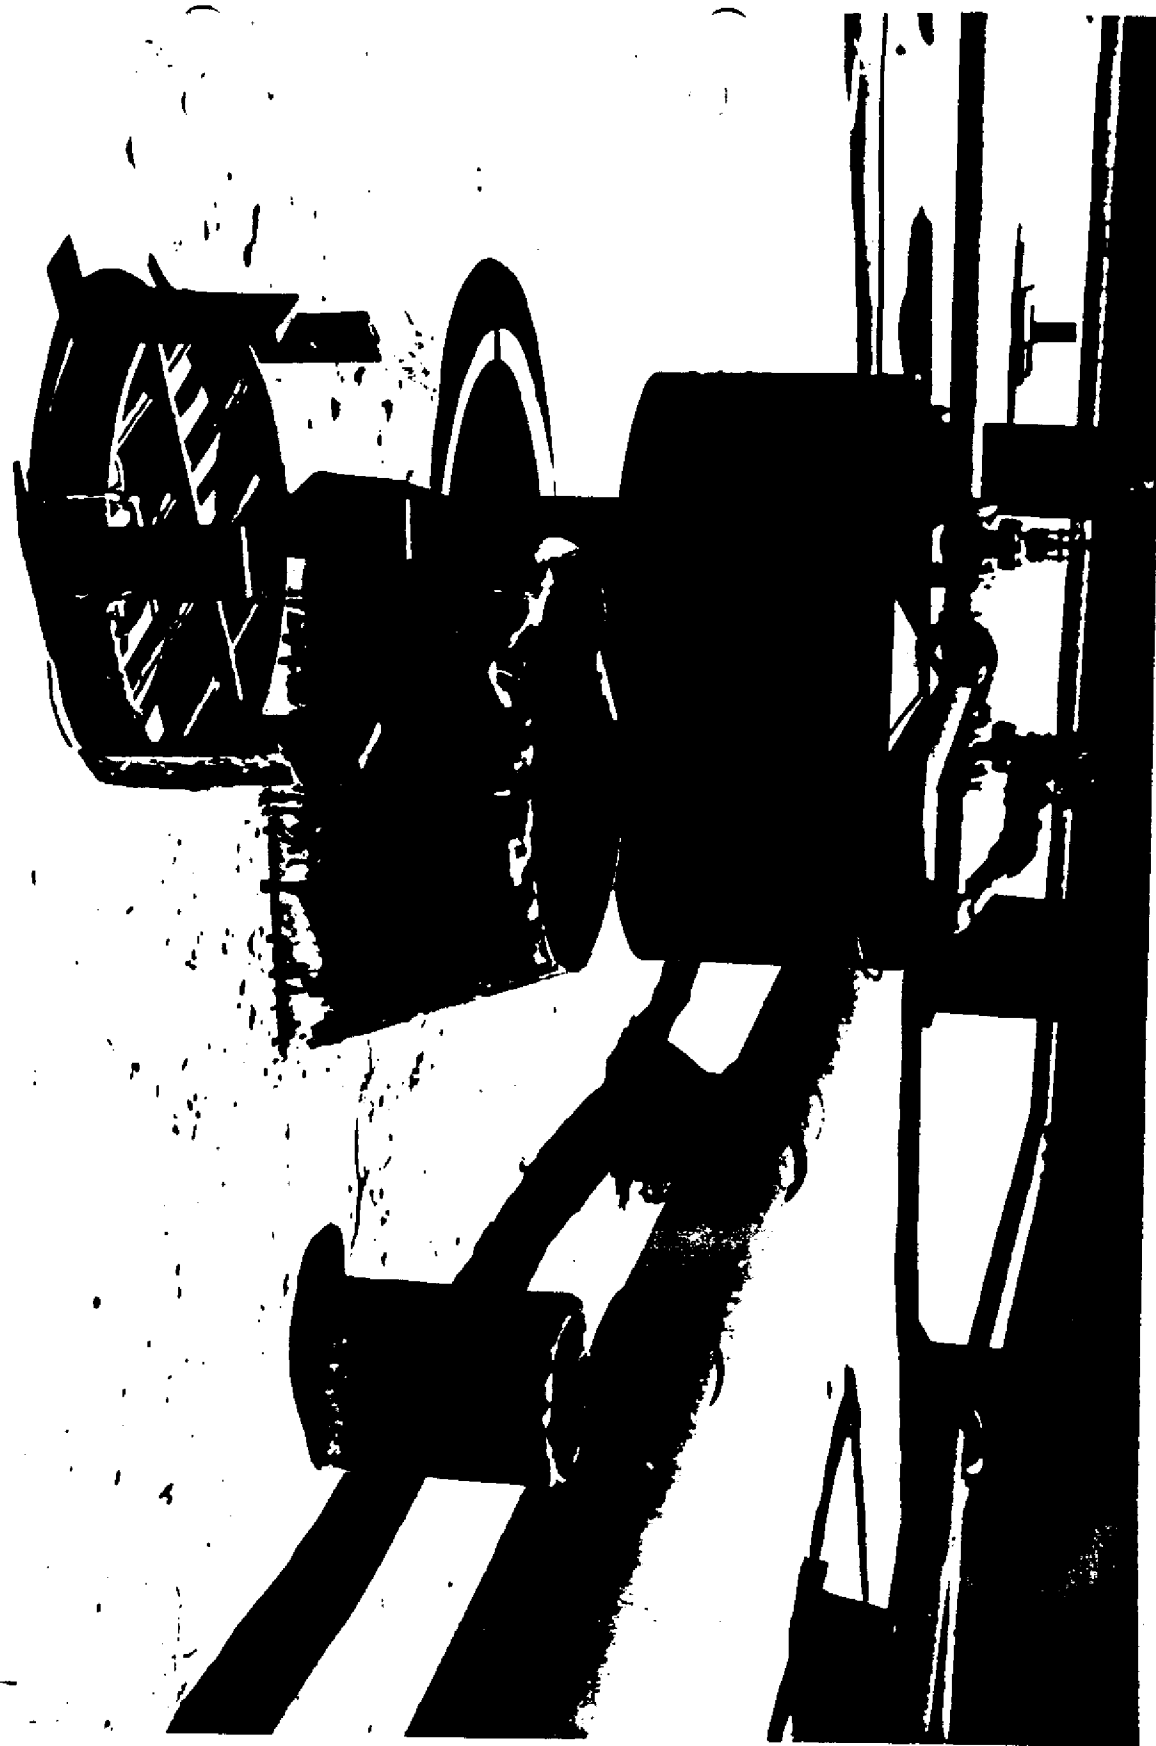
- 1-1 Photograph of ventilator on roof over Cell Block B. Photo taken looking south and shows in immediate foreground heavy iron grate which normally fits inside of funnel-shaped galvanized metal cone appearing immediately above grate. The object to the rear behind the opening is the ventilator top which was removed to permit the Subjects to escape.

The stub pipe appearing at center right is the vent stack for the lavatory facilities.

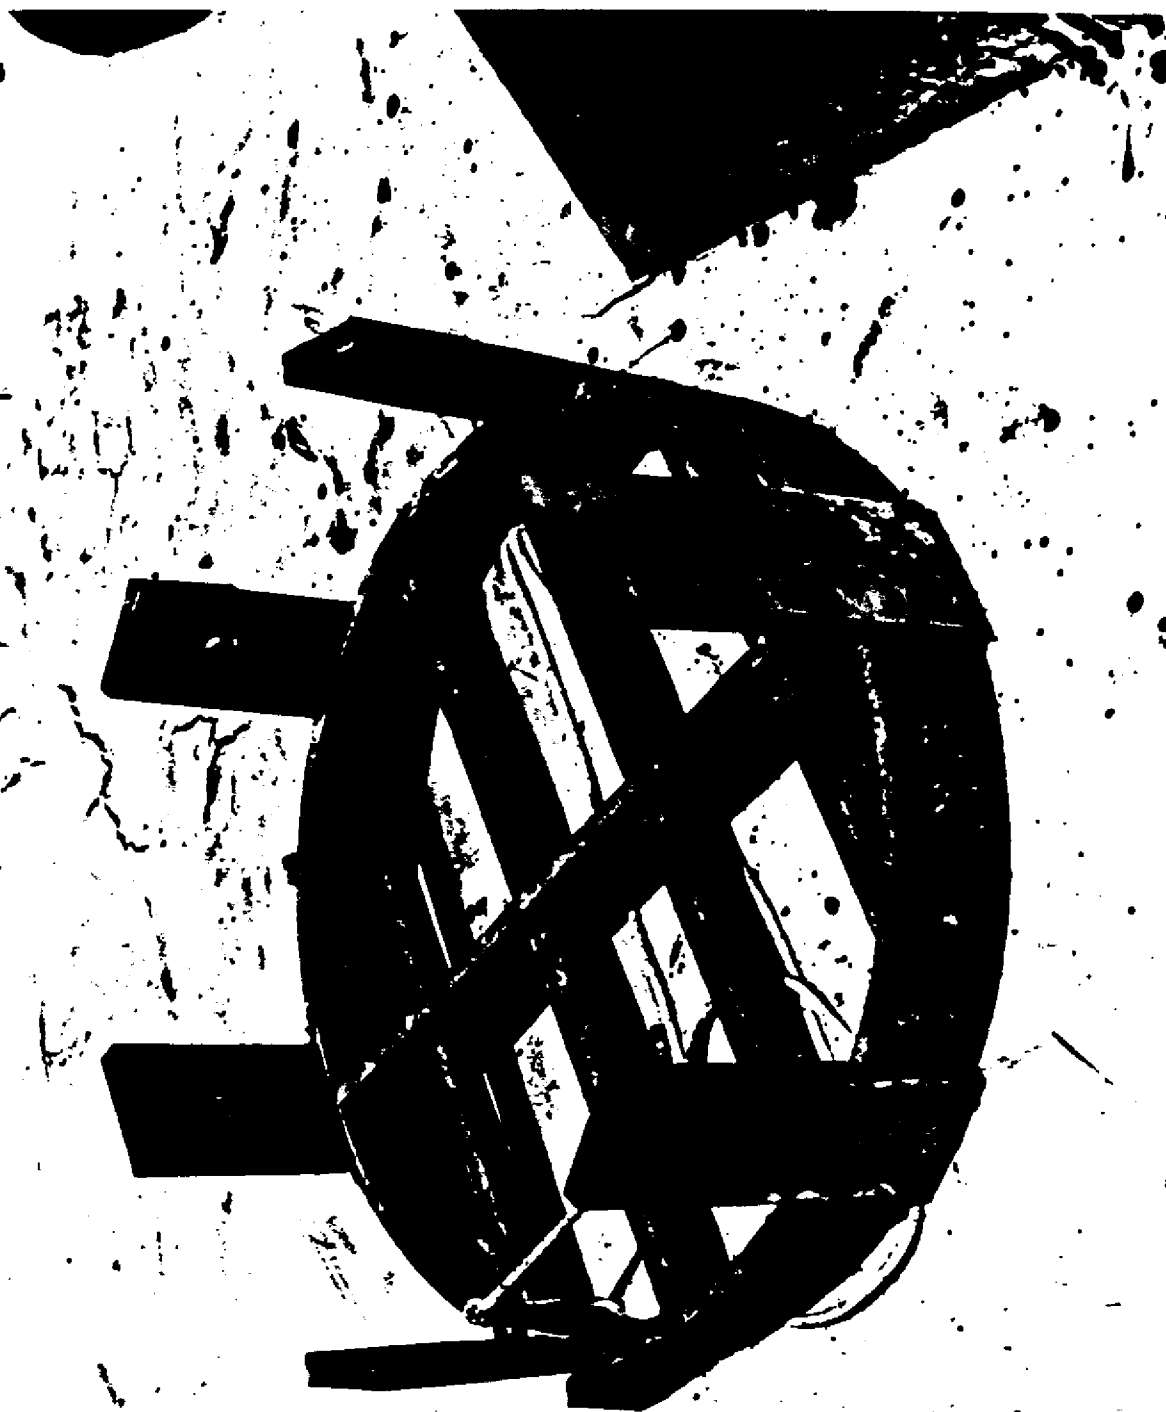
1-2 This is a more detailed photograph of the galvanized metal grate shown in 1-1.

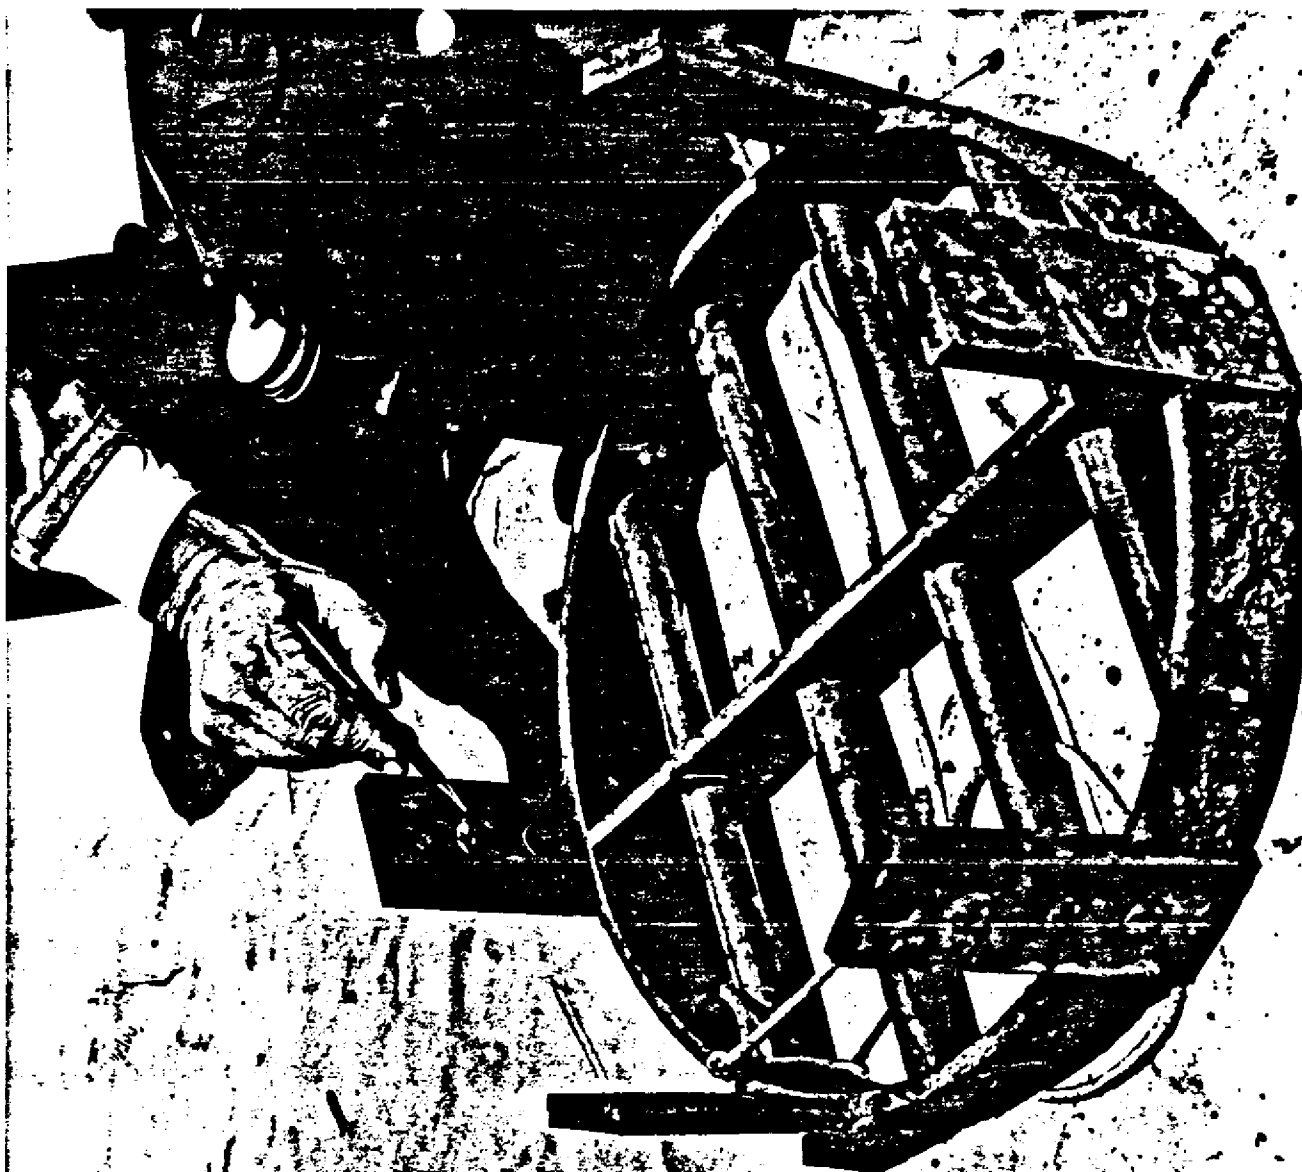
1-3 Same as 1-2 with the exception that pencil is used to point out the bolt head made of soap which is one of two found on the roof.

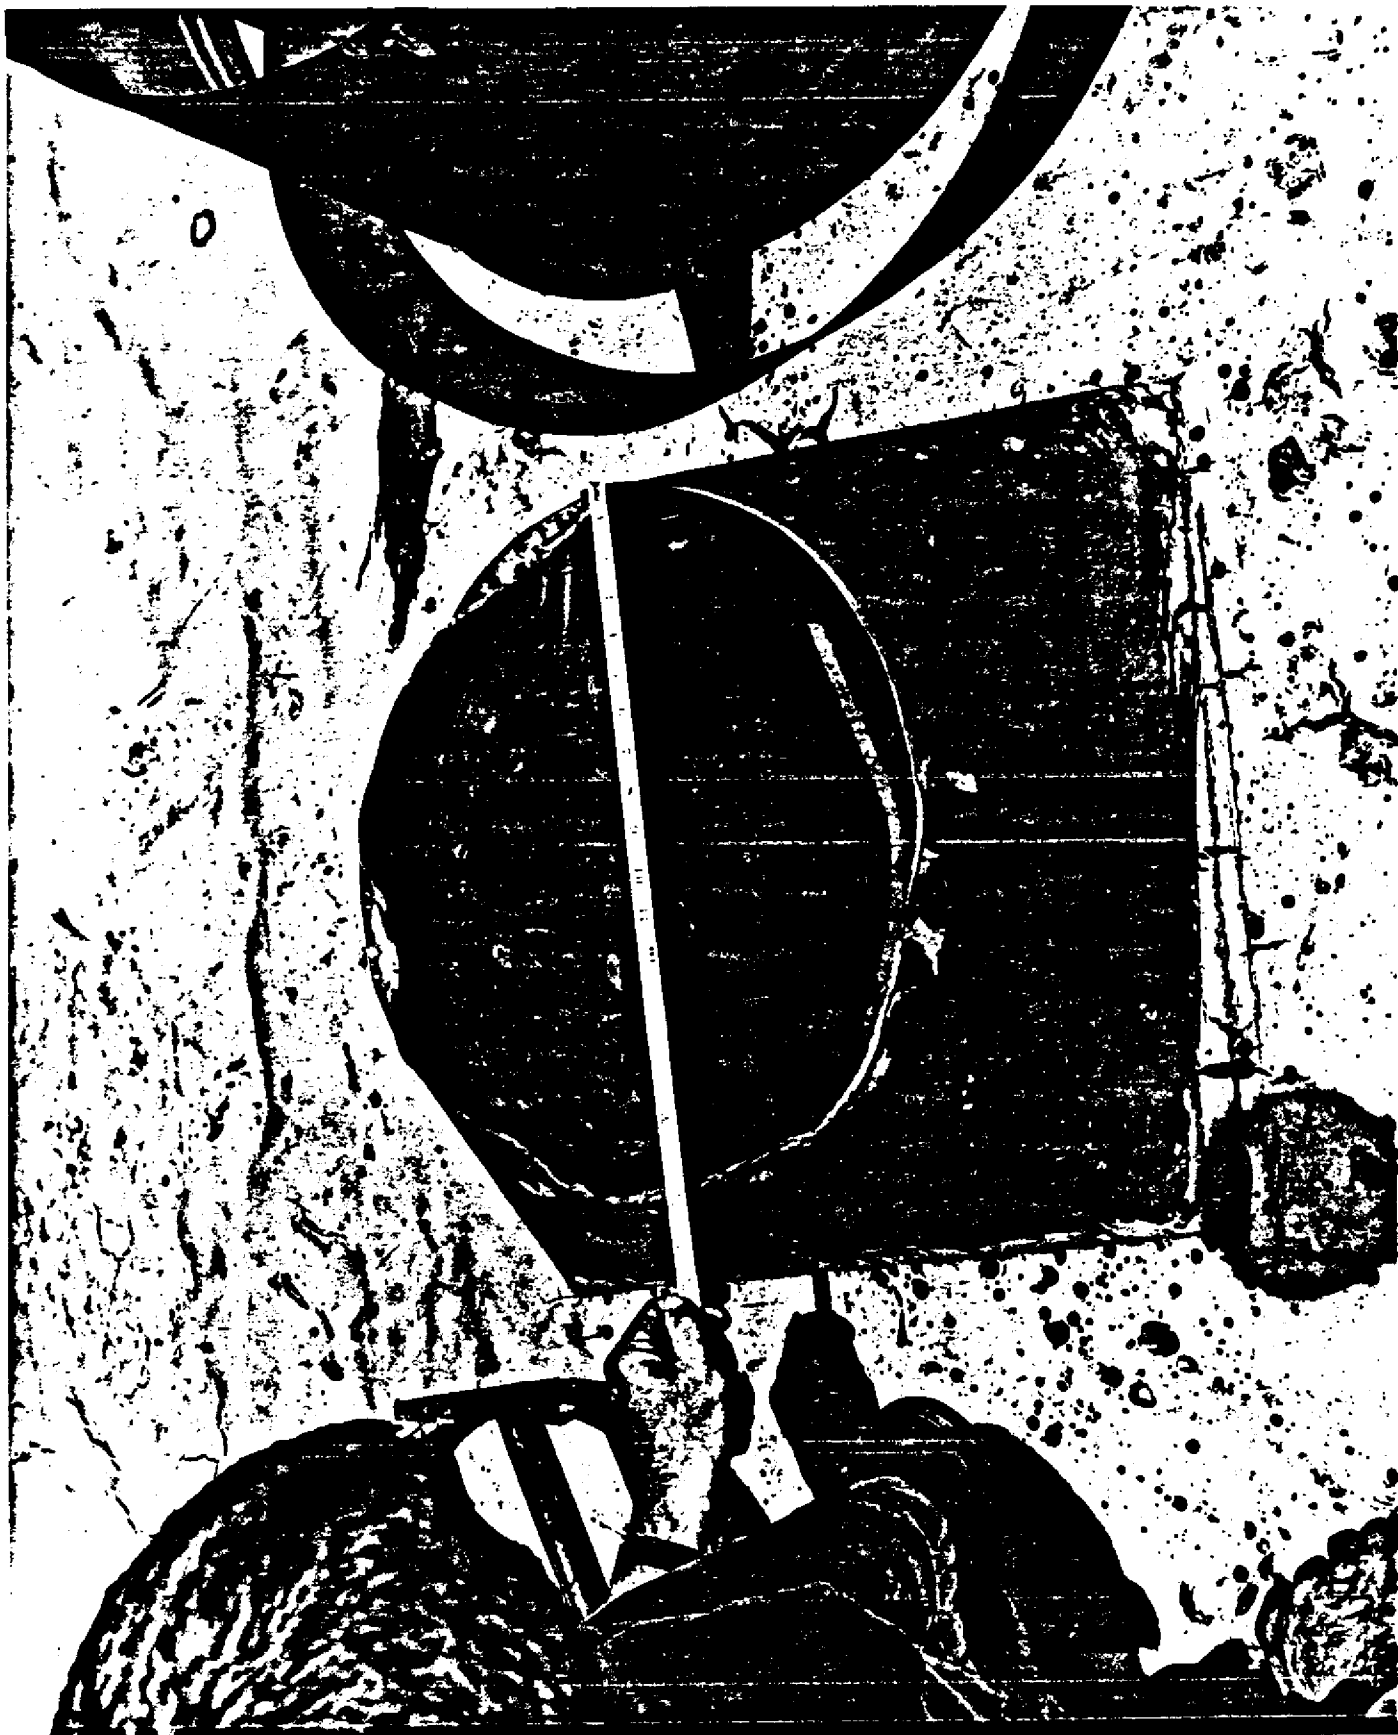
1-5 Photo same as 1-4 with the exception a tape is stretched across
the opening showing the opening to be approximately eighteen
inches in diameter.

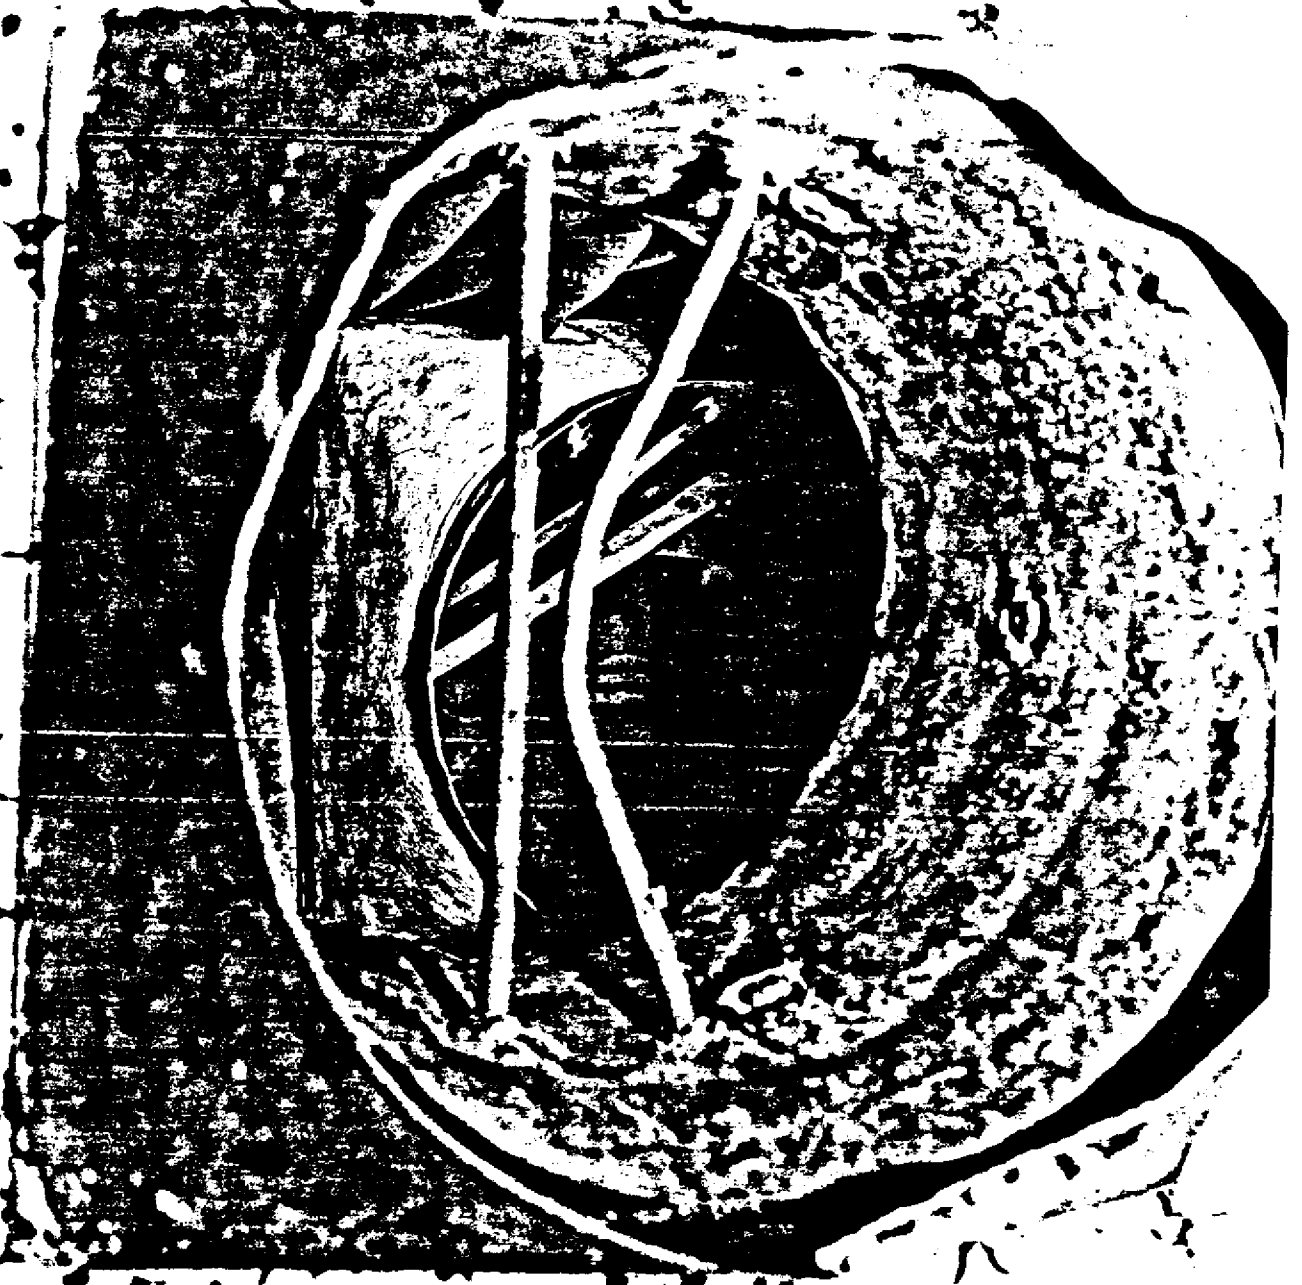
1-8 This photograph was taken directly over the ventilator opening on the roof and shows the vent re-enforcing rod and the stud holes normally used to fasten down the heavy galvanized grate shown in photographs 1-1, 2, and 3. Immediately below the opening may be seen the top of the motor housing which is normally offset from the roof opening and when in operation is joined by a galvanized gooseneck connection. The blades of the "squirrel cage" type air impeller may be seen just above the bent portion of the re-enforcing rod. The bent rod is on the eastern side of the hole.

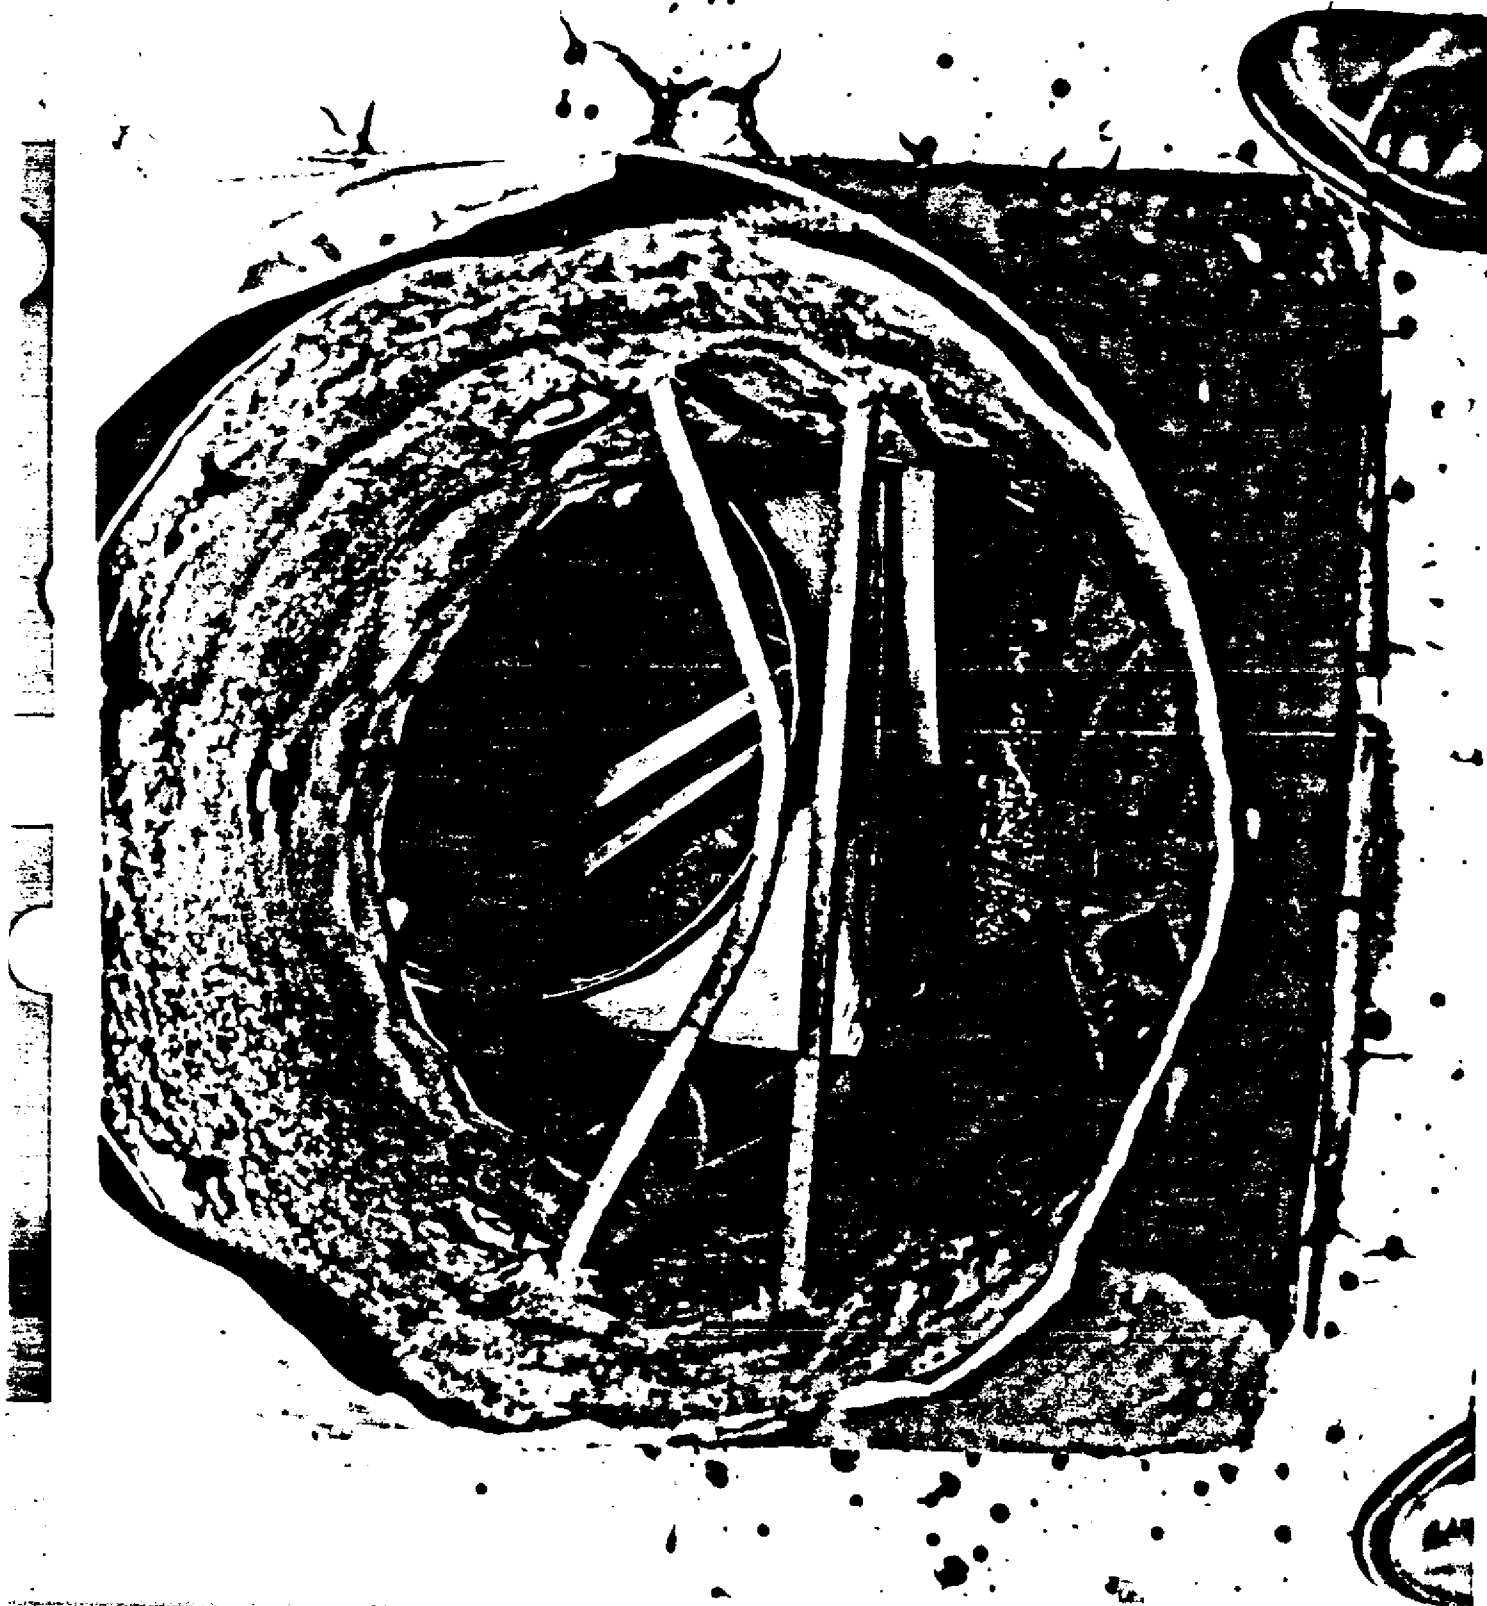
1-9 Same as 1-8 with the exception that more detail is shown concerning the blankets which were used to shield light from entering this opening.

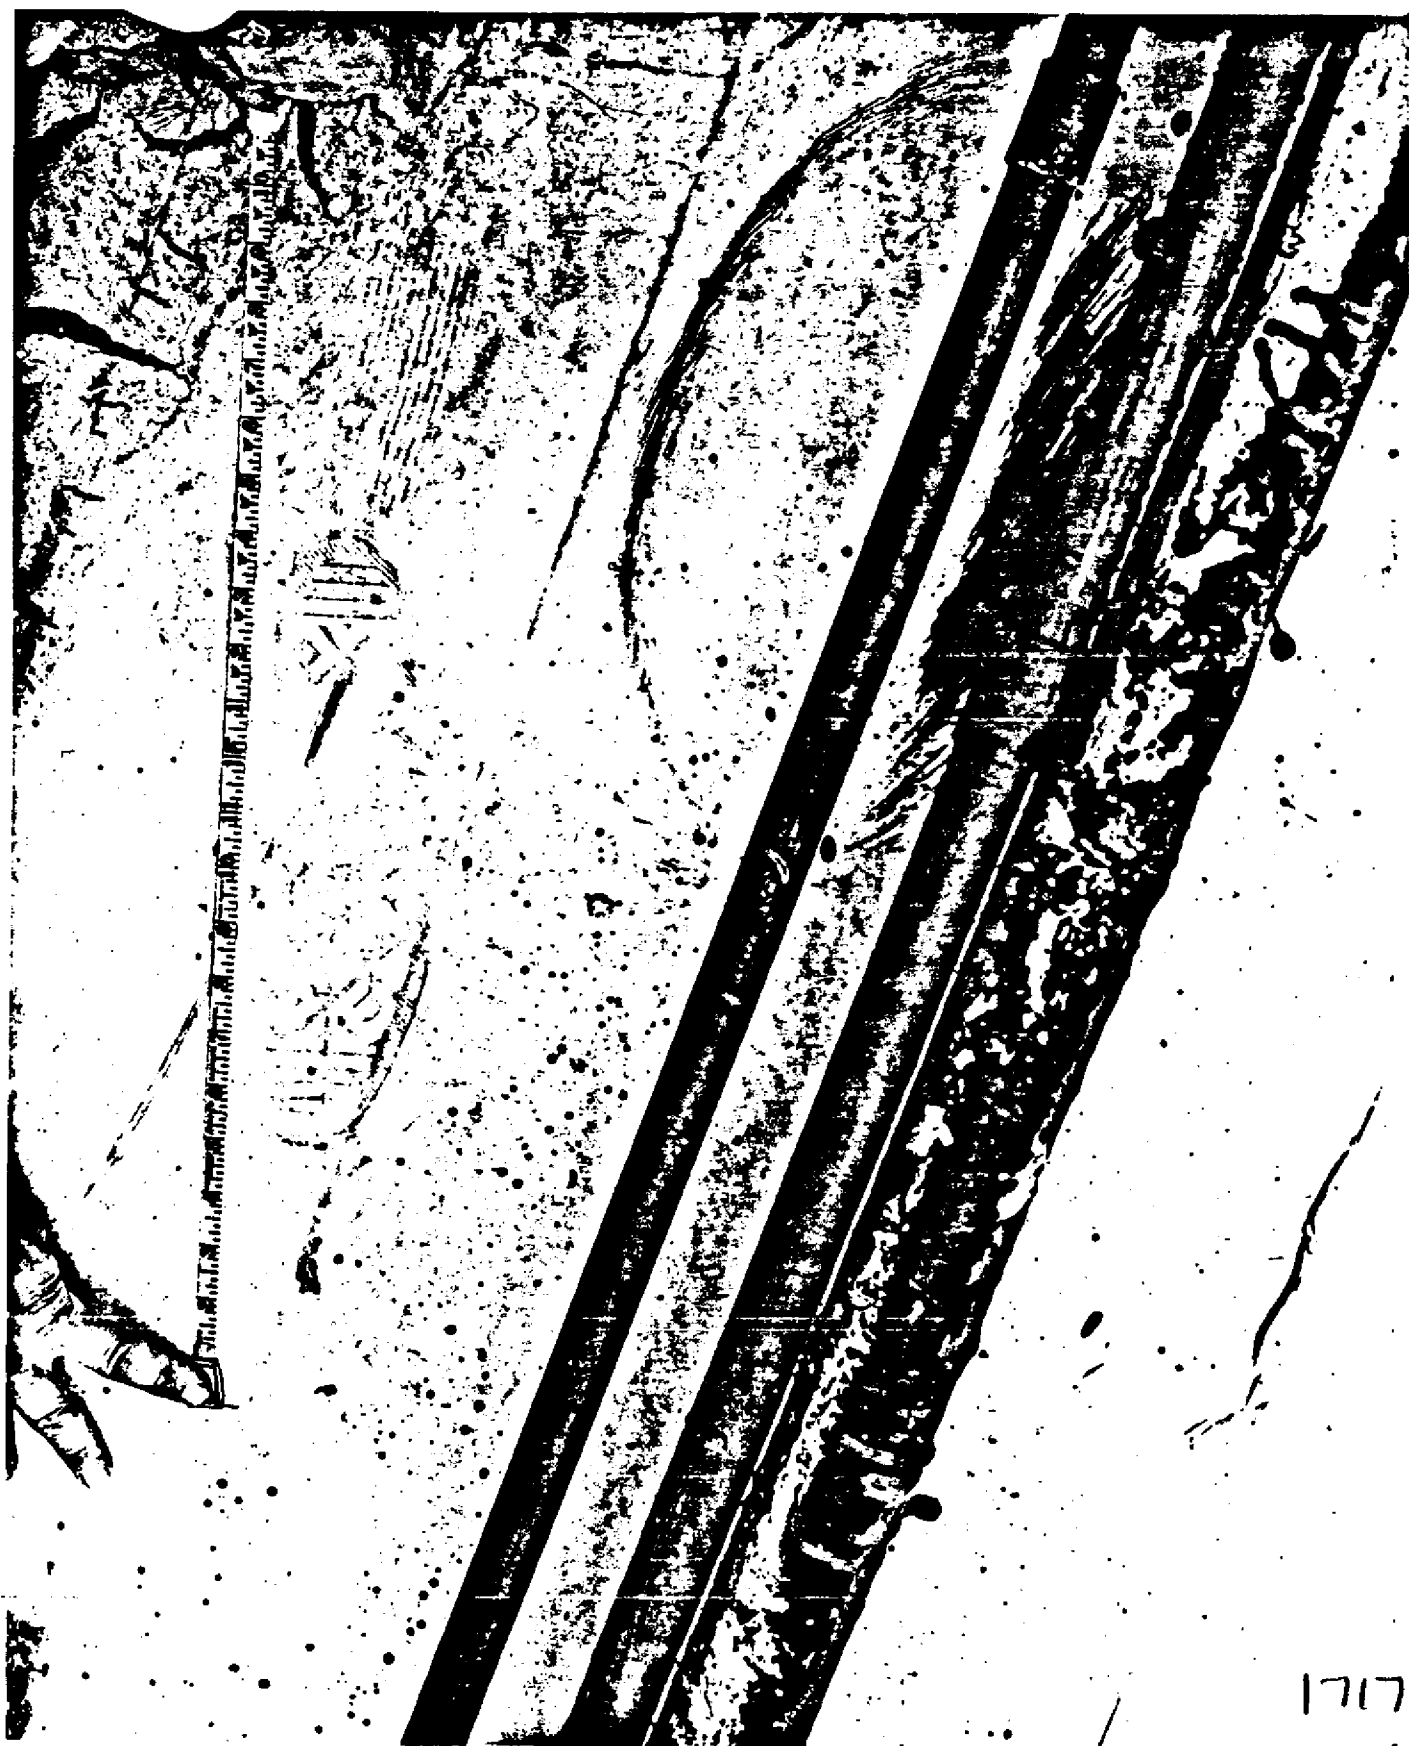
1-10 This is a photograph of an imprint of what appears to be the left foot. This print is headed in a northwesterly direction. The imprint appears to be that of the sole of a tennis shoe and is one of a number of fragmentary such prints visible on the roof indicating the direction of travel.

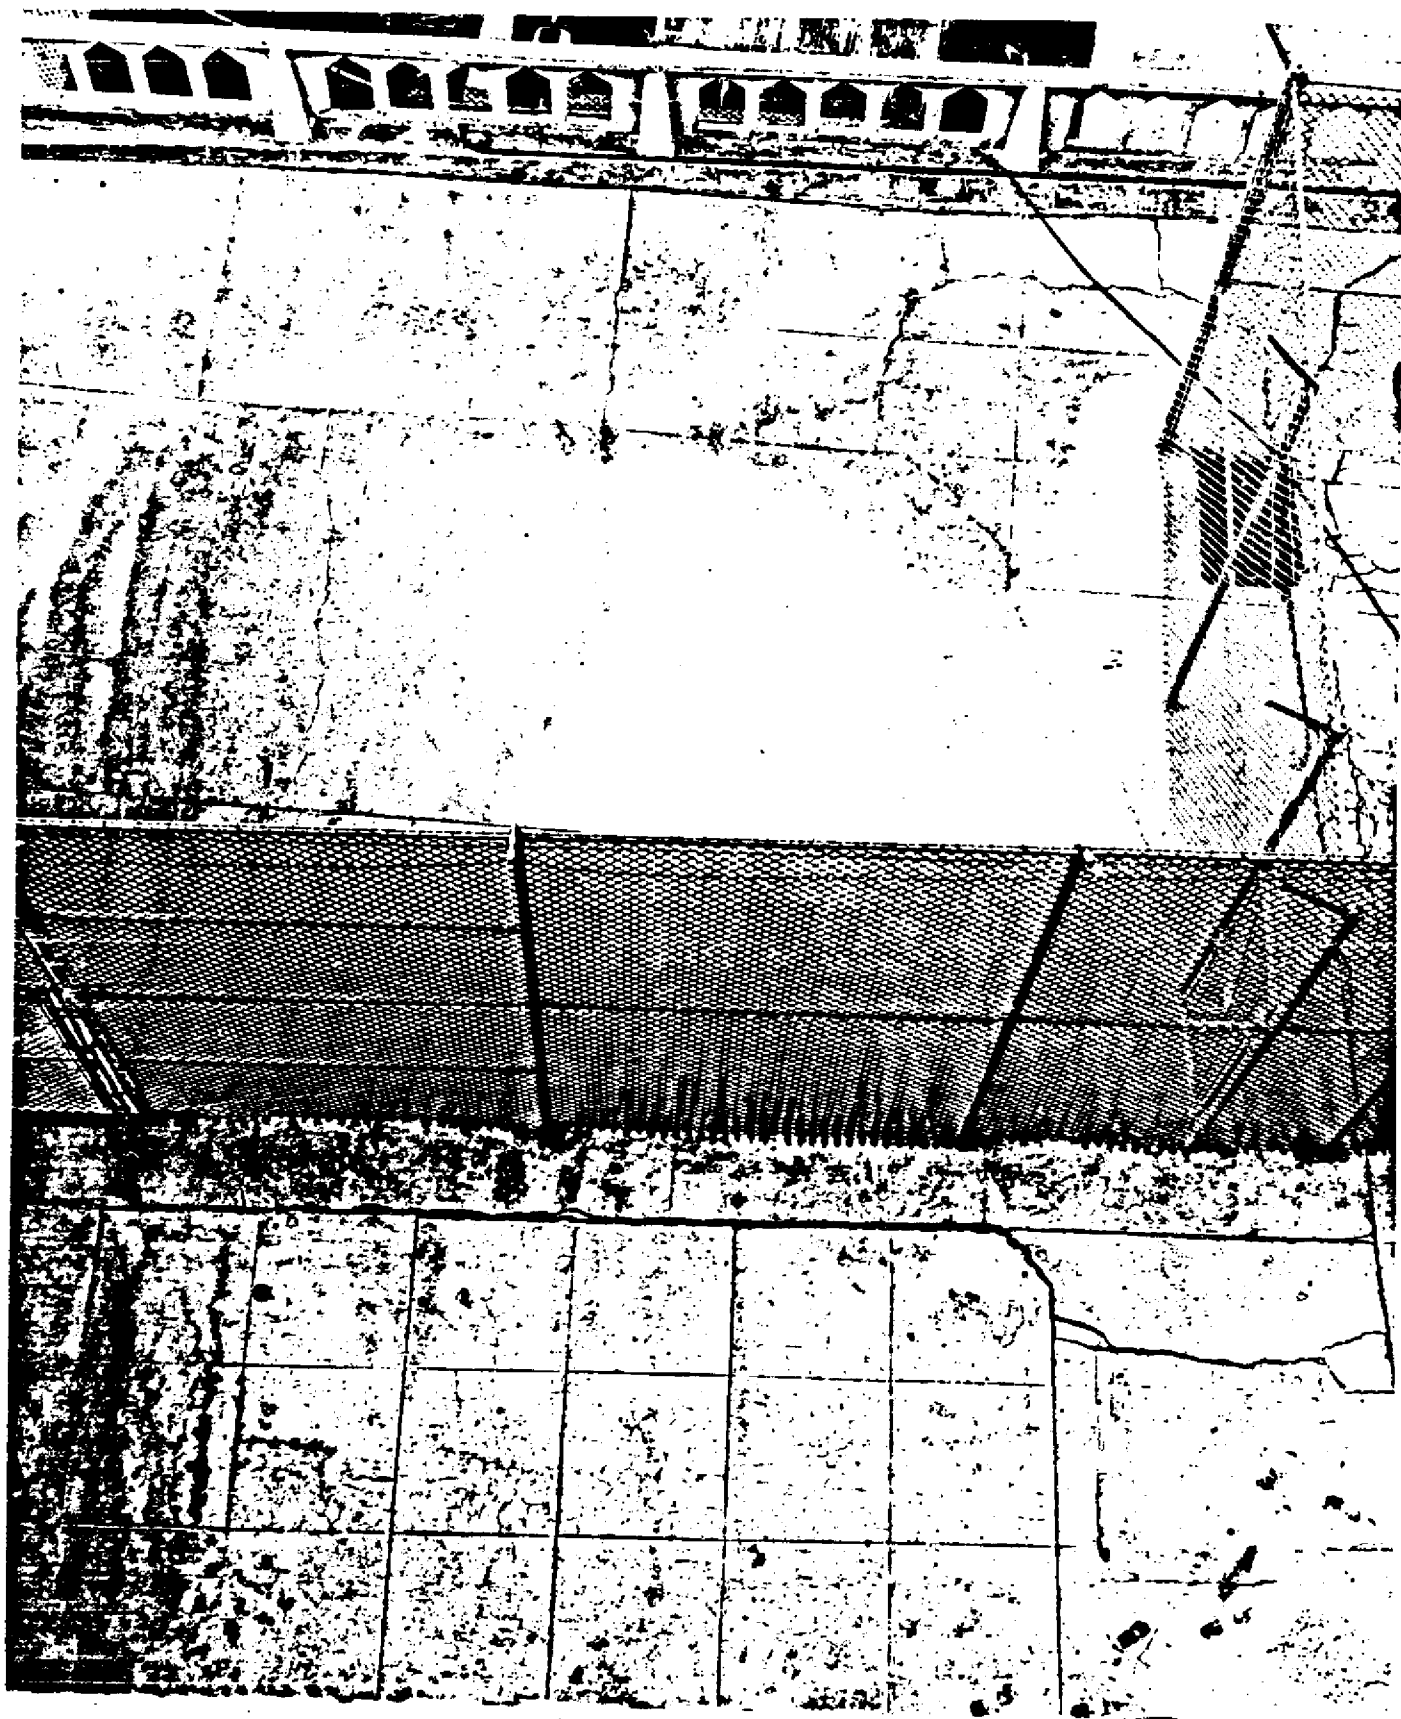
1-12 This photograph was taken from the north end of the building looking down to the enclosed ground area which is believed to be the area the Subjects descended to. The distance from the top ledge of the building to the concrete shown in the lower foreground is approximately forty-five feet.

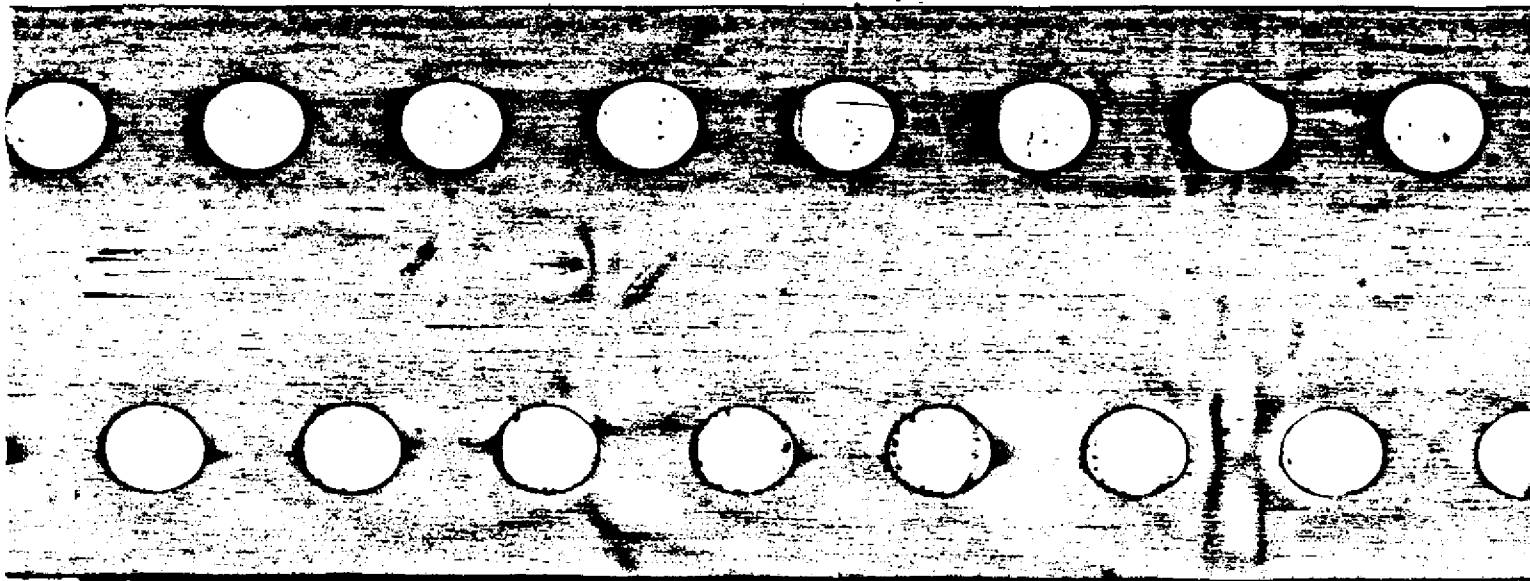
2-1 Photograph taken from top of prison building looking in a northern direction. The concrete decorative wall shown at bottom of photograph is the same as appearing at the top of 1-12. The two tanks shown in the foreground are salt water tanks with the base of the water tower shown at upper right. Top center is guardhouse number 3 and is not manned during the night hours. It is noted that lower left center along the fence, which encloses the walk to guard tower number 2, the barbed wire appears to have been cut and may have been the area over which the Subjects were able to make their escape.

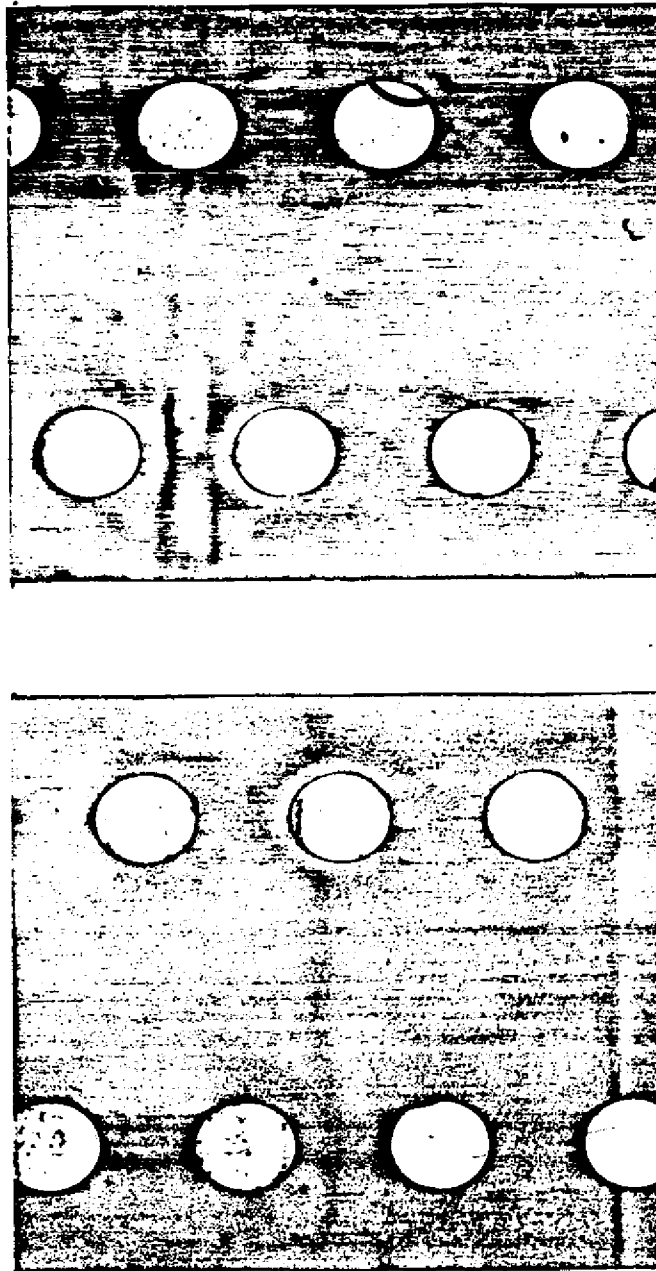
2-5

Photograph taken from roof as in preceding photograph, however this photograph shows the type of electrical fixture used to flood the sides of the building with light during the evening hours. Two such lights are spaced across the narrow or protruding end of the prison building and are spaced approximately ten to twelve feet apart. These lights receive their power from an externally mounted outlet on the inside of the edge of the roof and all connections were found to be tight and show no indications of having been tampered with. All lights were found to be in working order and were illuminated at the request of the photographer. The area at lower right is leading to the water line. It is the area believed to have been used by the Subjects in reaching the water.

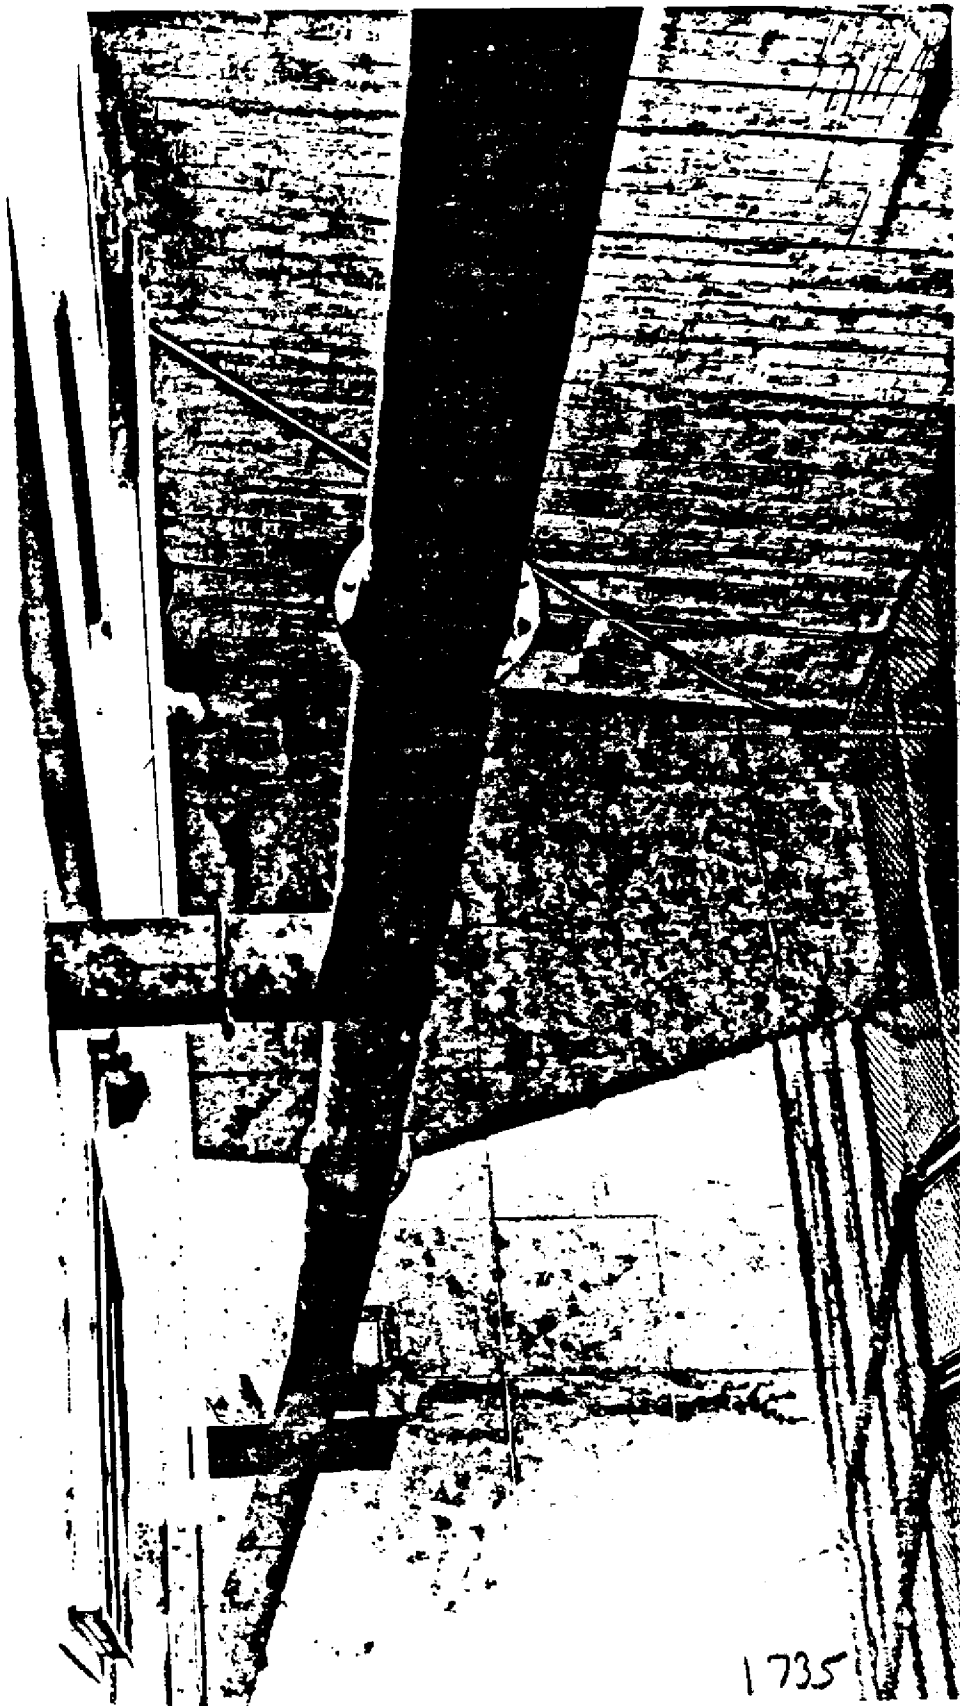
2-7 Photograph taken by leaning over the edge of the building showing the bake oven stack extending from above the roof line to the clean out on the concrete slab at ground level. The edge of the building is at left center and the distance from this to ground level is approximately forty-five feet. The wire screen topped with barbed wire seen at lower right is approximately twelve feet high.

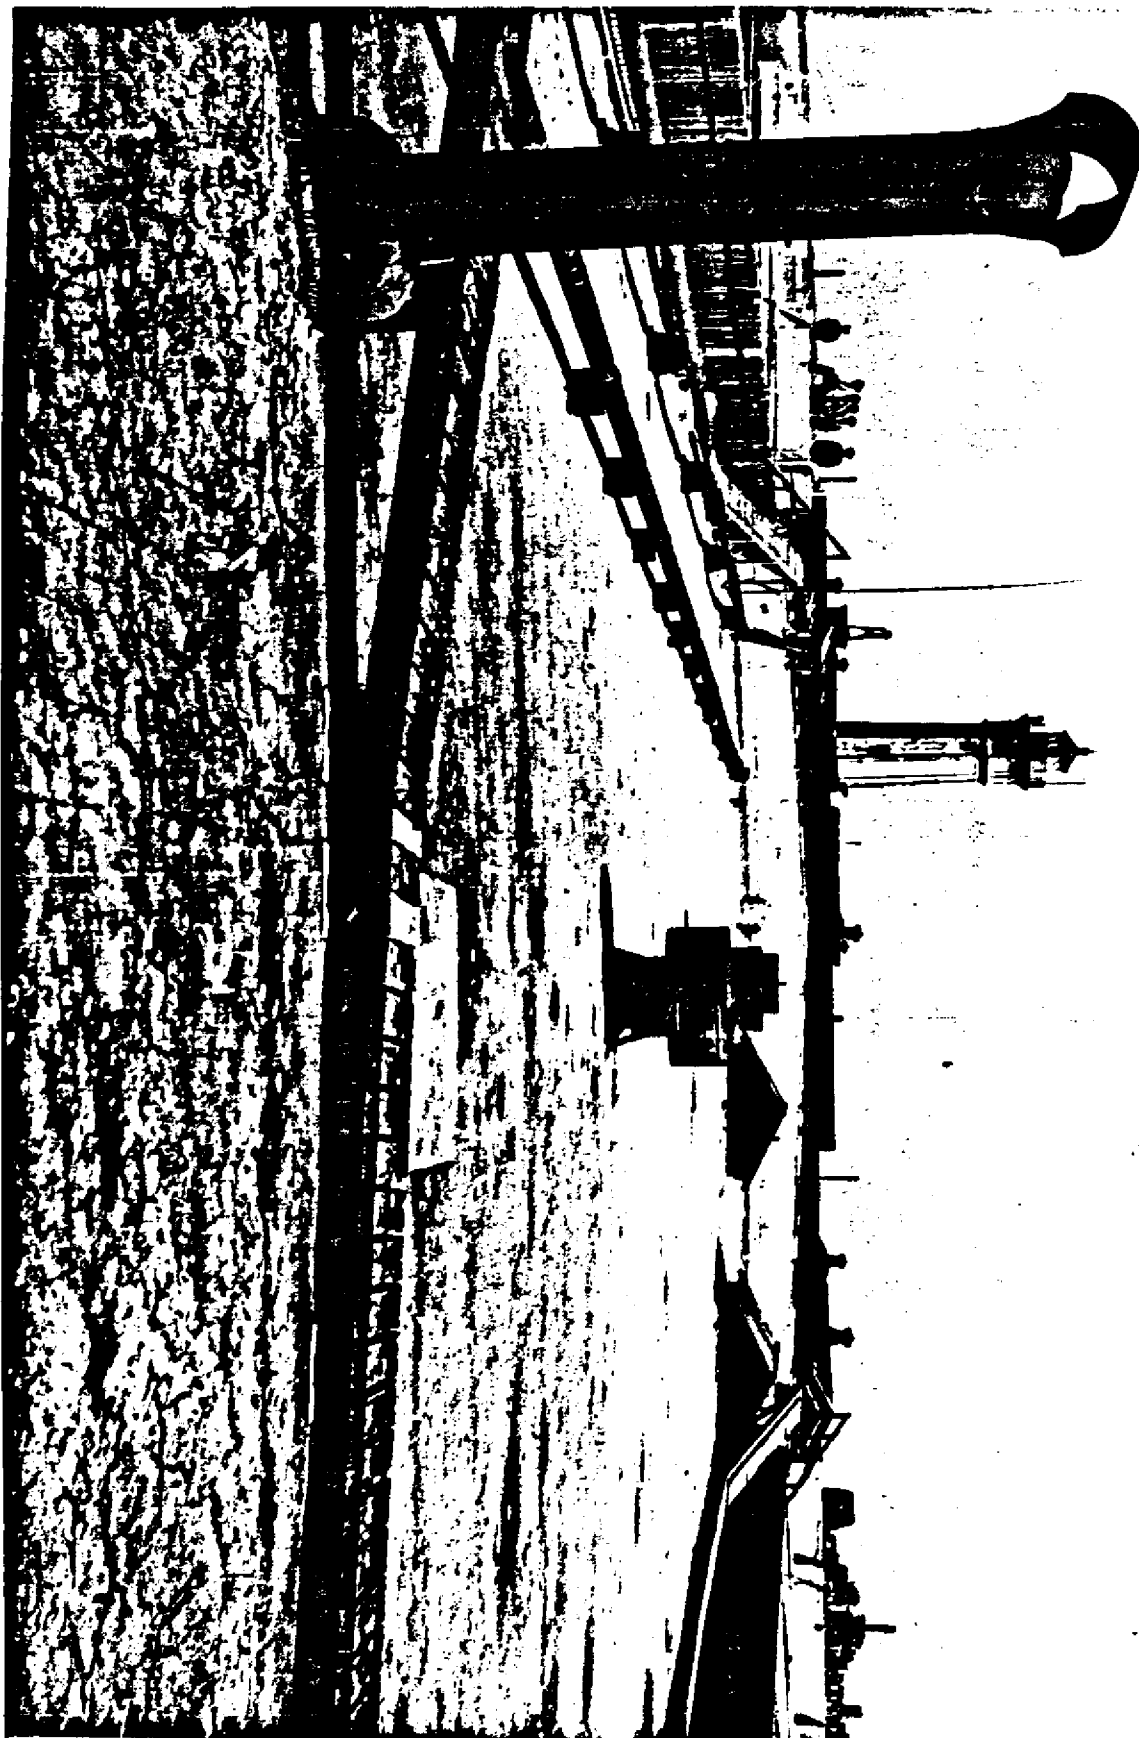
2-10 Photograph taken showing general roof area looking in a southerly direction from the bake oven stack toward the Coast Guard lighthouse. The change in the roof elevation from Cell Block A, B, and C, etc., may be observed with catwalks running on both sides of the picture. A paddle was found under the catwalk in approximate location indicated by the individuals seen in the photograph left center.
