SUBJECT John Anglin, Clarence Anglin and
Frank Lee Morris Escape from Alcatraz

FILE NUMBER 76-26295

VOLUME NUMBER Enclosures 76, 137, 155 and 179

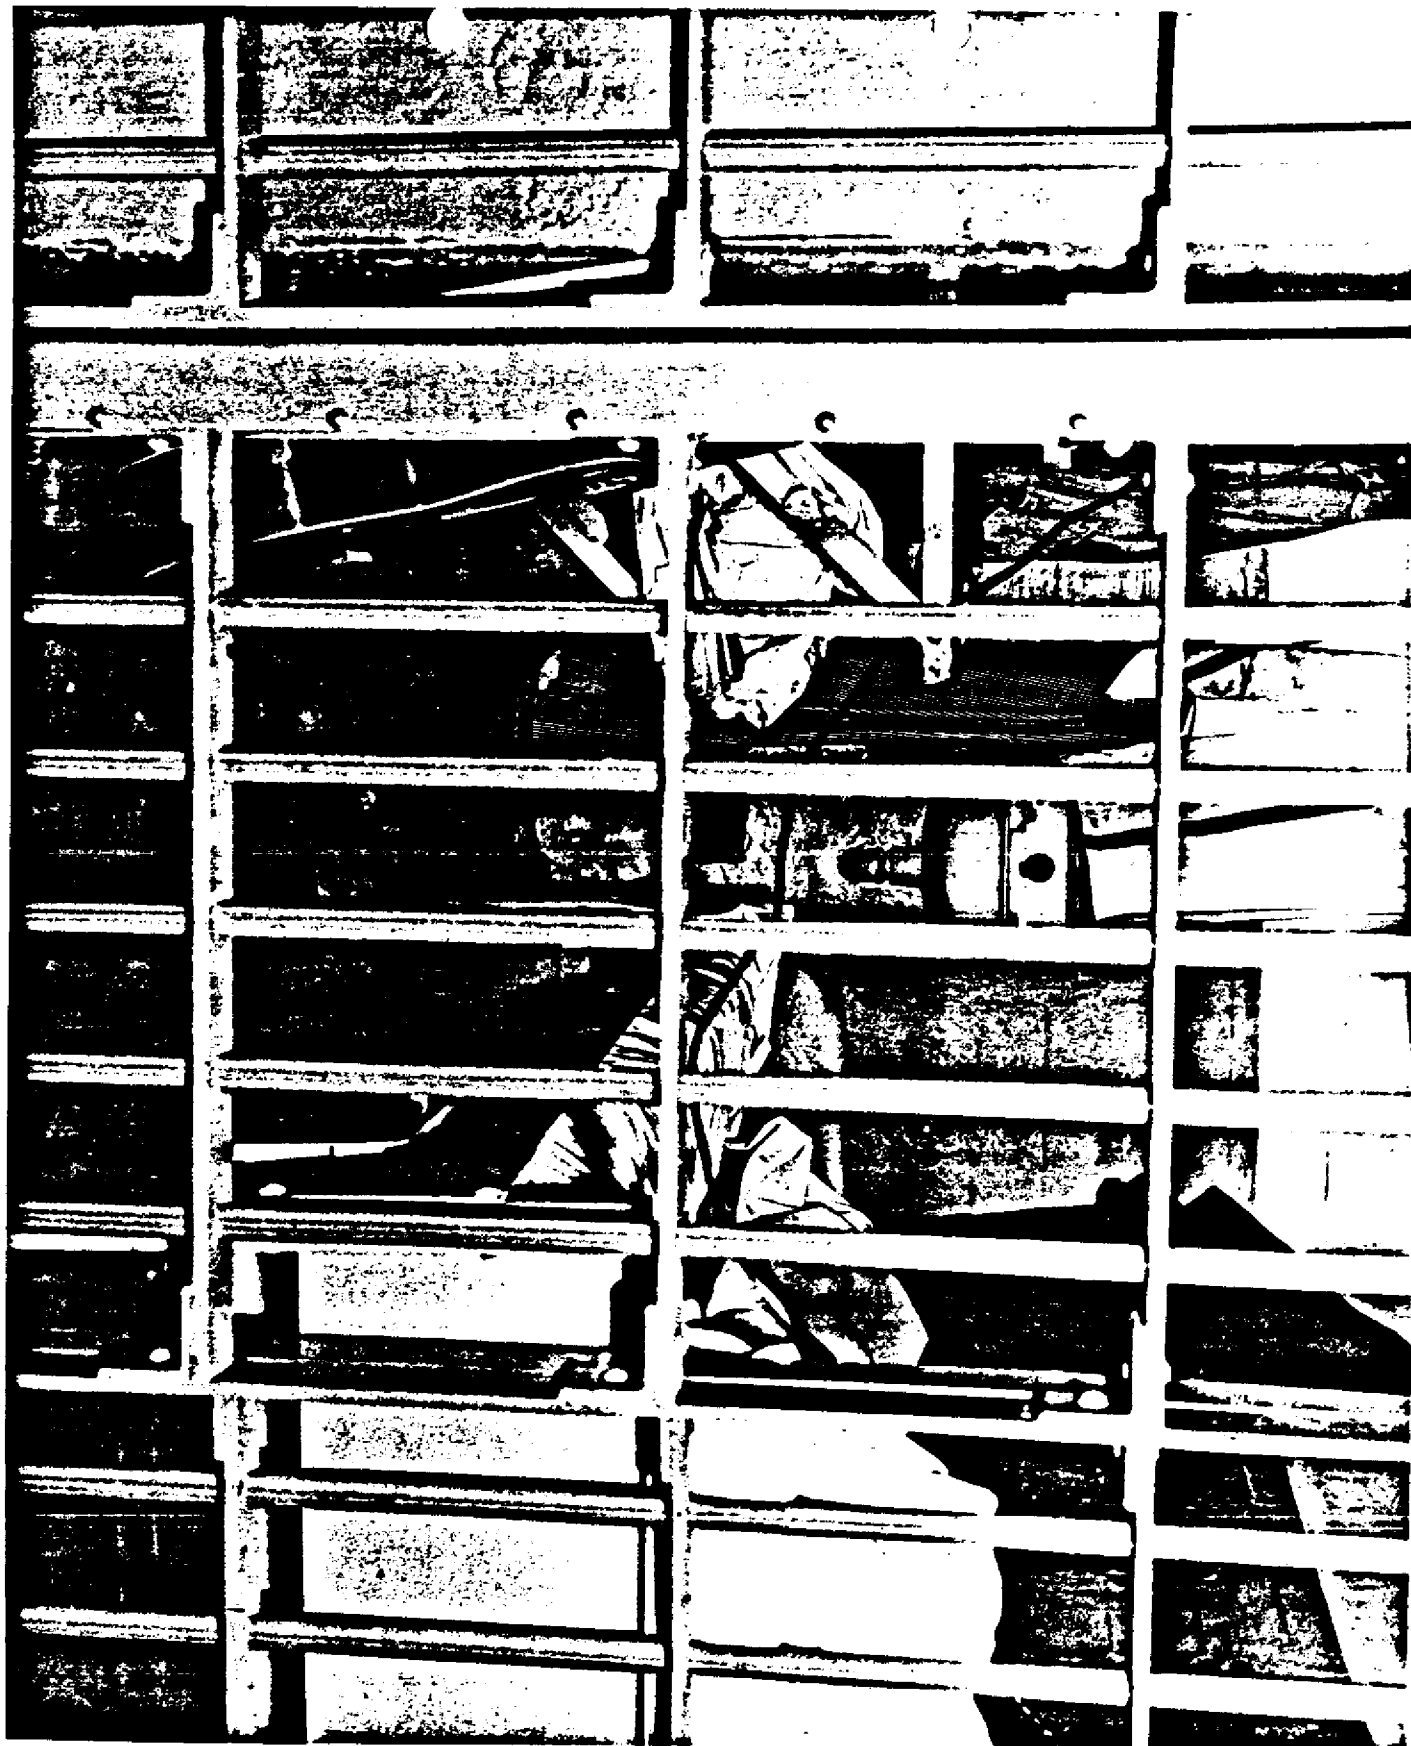
~~3-2~~
3-2

3-2 Photograph of the same cell taken head-on showing the opening at the rear of the cell under the wash basin which permitted Subject CLARENCE ANGLIN to escape. In this photograph the hole is partially covered by a piece of cardboard, the source of which and use of which is unknown.

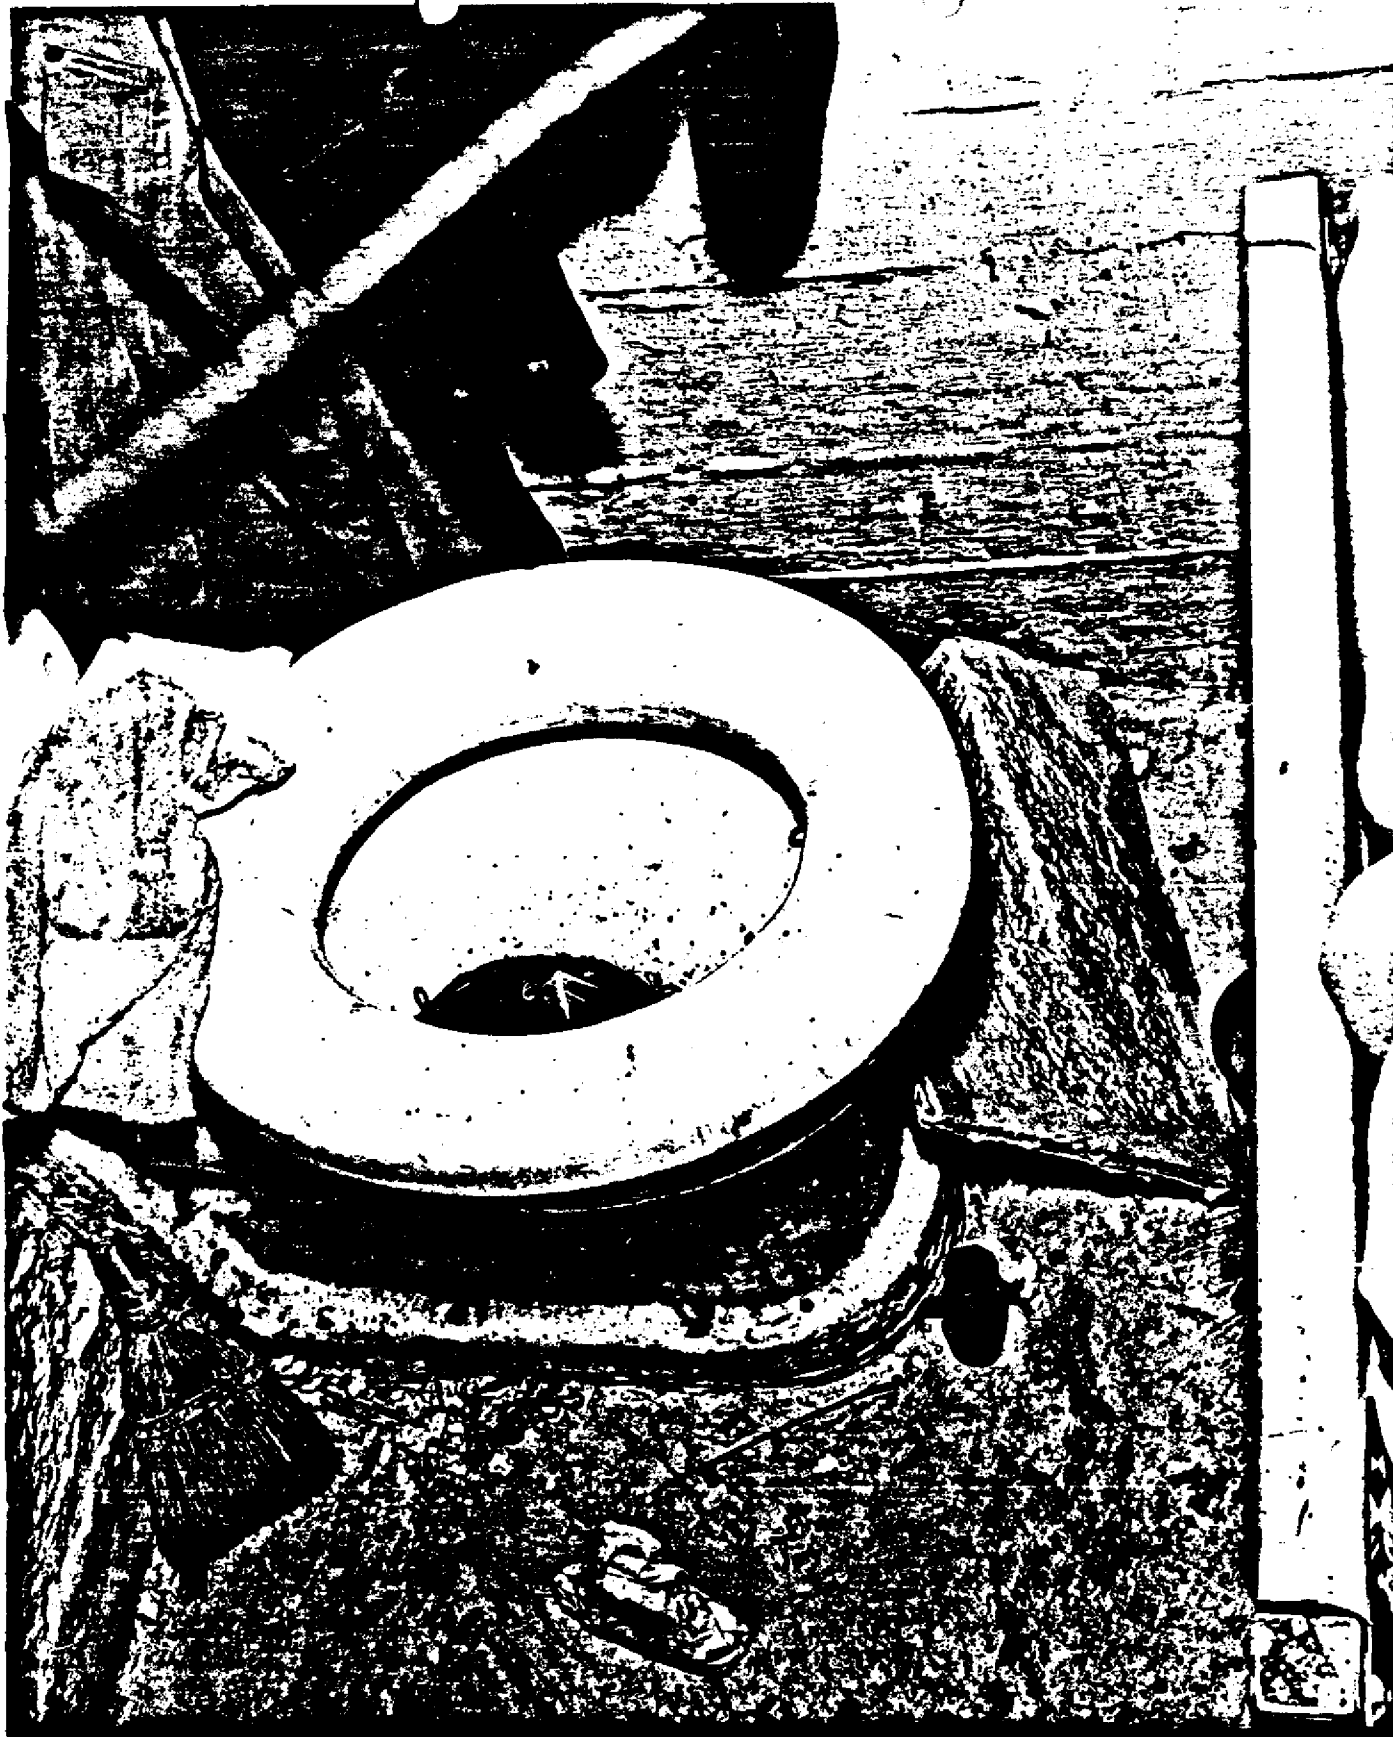
3-4

Photograph taken in the cell of CLARENCE ANGLIN showing detail of toilet facility at foot of bed. Portions of soap scraps and plaster are visible as are fragments of hair. Immediately forward of the toilet seat is a portion of the grill made by Subjects to replace that removed from the cell. The portion of the small circular object seen is the cup which is supplied to prisoners for shaving purposes. This cup contained water and a brush.

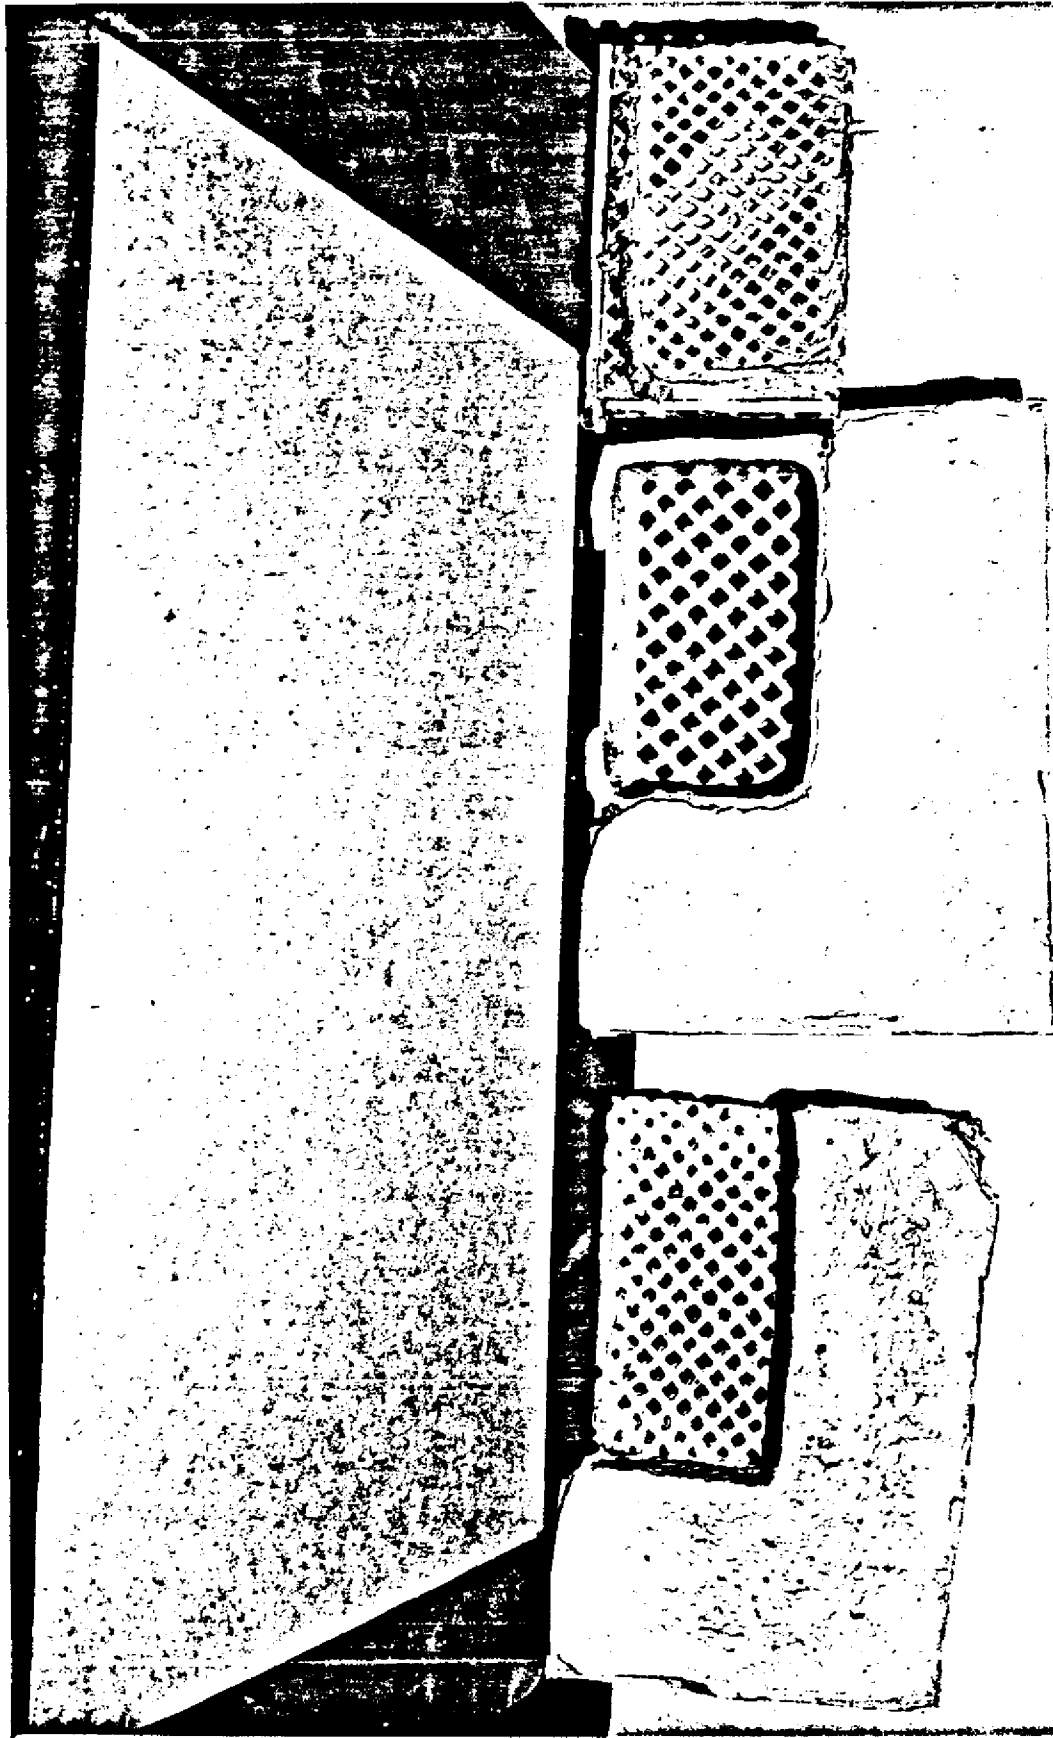
Replicas of ventilator grills placed in openings in cells through which Subjects exited to utility area between cell blocks B and A. Replica on the left is the actual size of the metal grill originally in the wall; it was reproduced, as were all the rest, from artist's drawing board which was faced with a linen-type substance. This material is available to all inmates for art painting purposes.

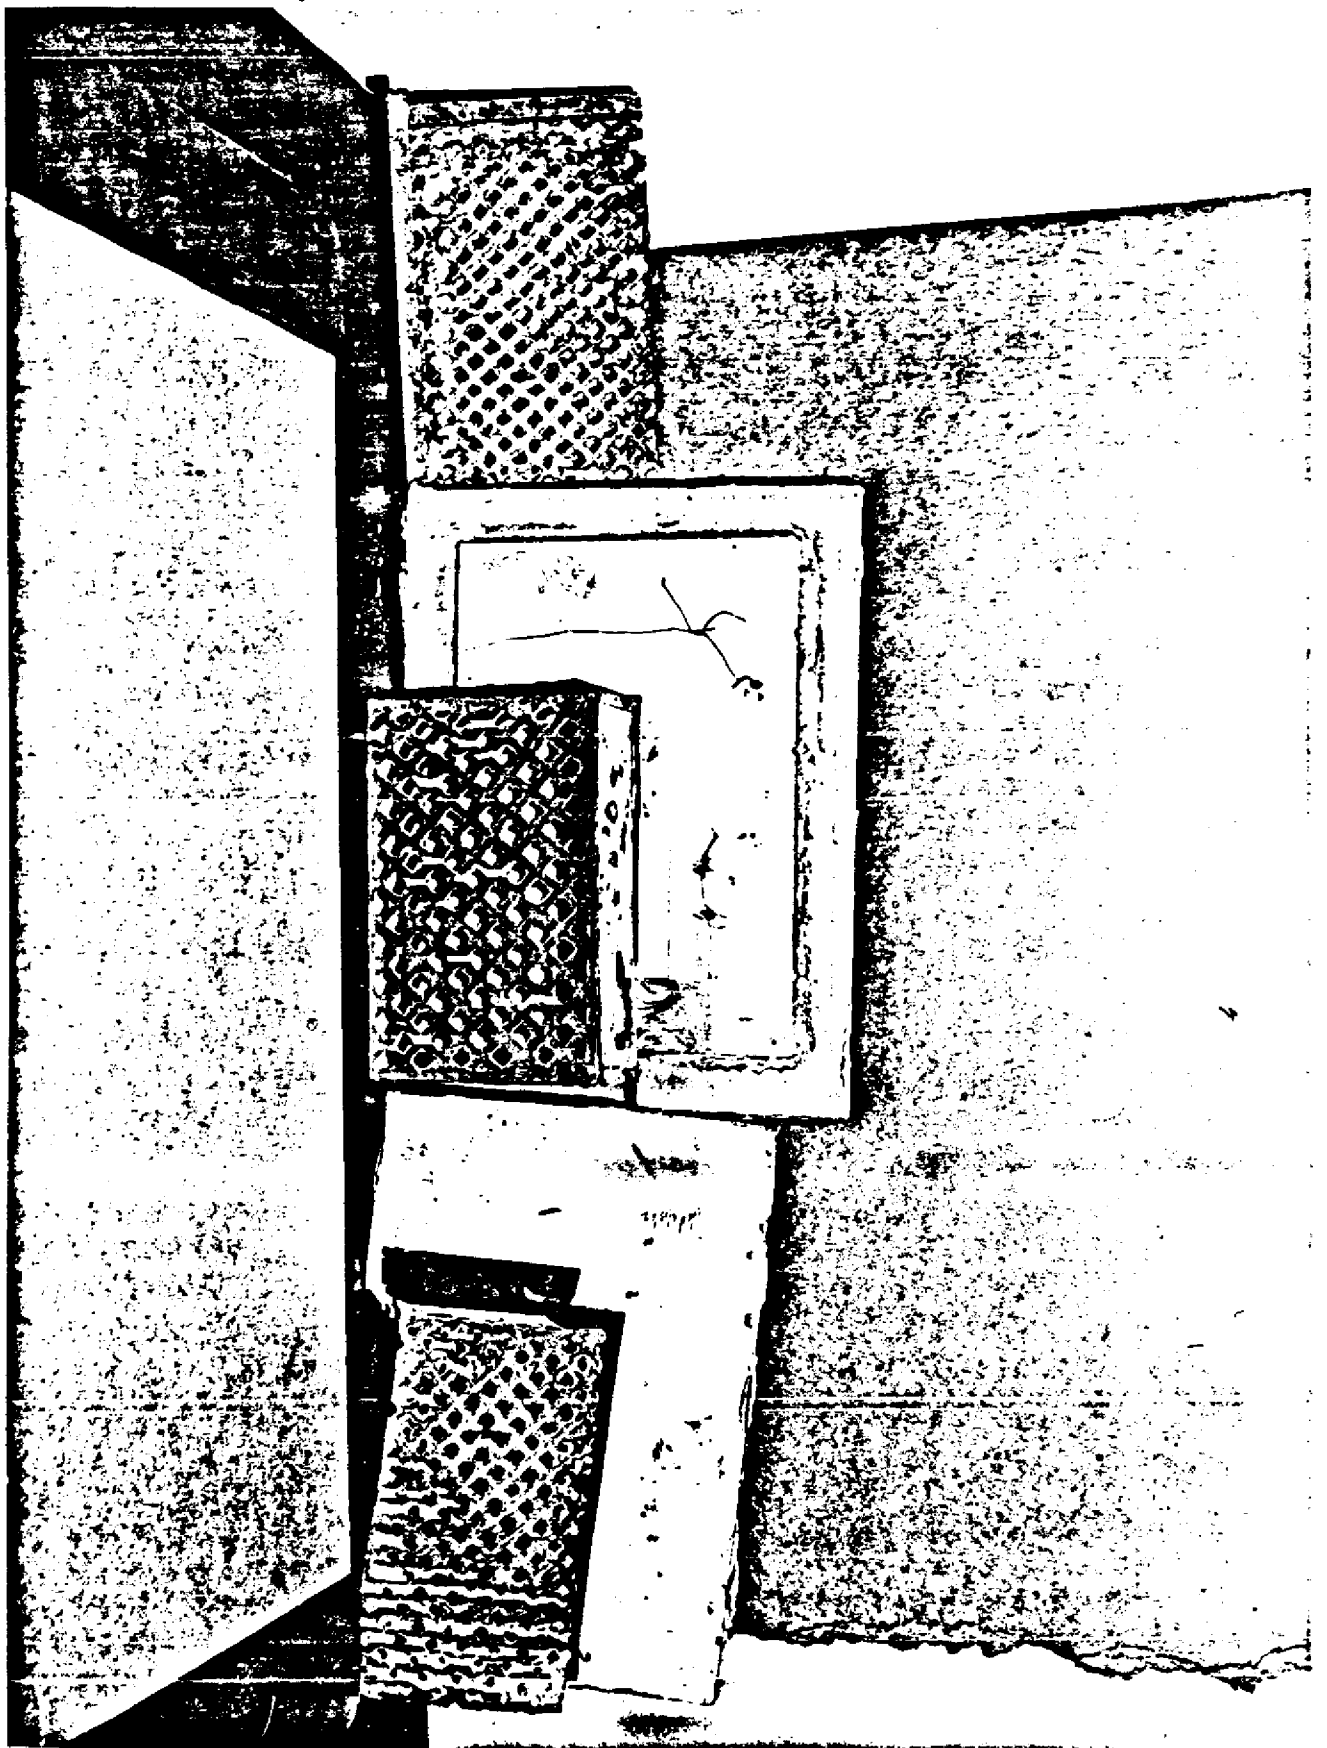
Rear view of three replicas of ventilator grills used by Subjects to replace original grills in their three cells. Note wire hooks by which grill and surrounding surface could be pulled into place after Subject's exit into the utility area.

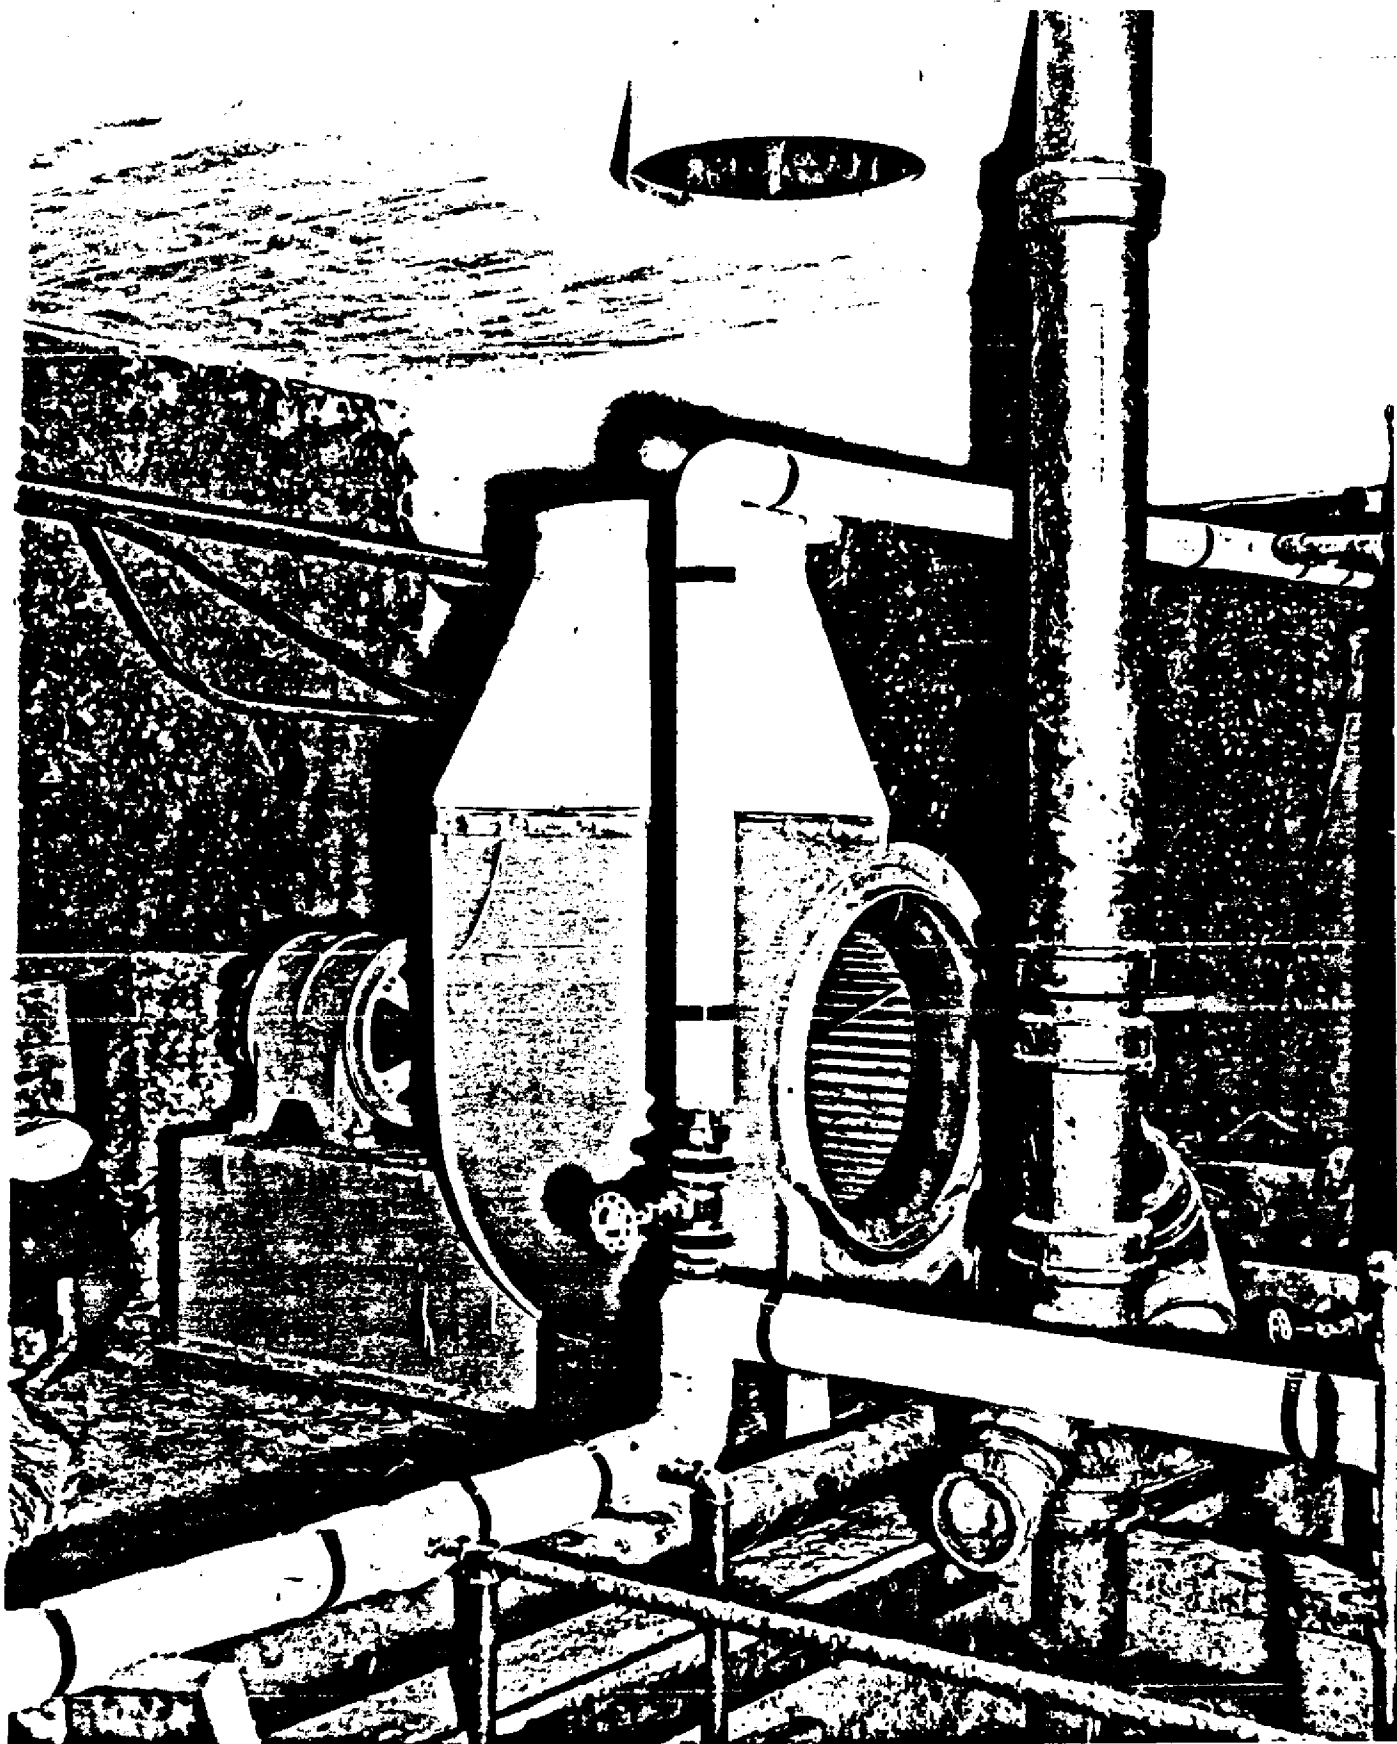
3-10 Photograph taken of the abandoned ventilating fan with opening through to the roof. Left rear and center background shows the manner in which this area was completely enclosed by drop cloths and blankets hung ostensibly to prevent splattering of paint into the cell block.

It was in this ventilator that the abandoned pantoon and two bundles of raincoats were located. Articles at the bottom of this ventilator could be reached by a long pole which had a nail protruding and could be used as a hook.

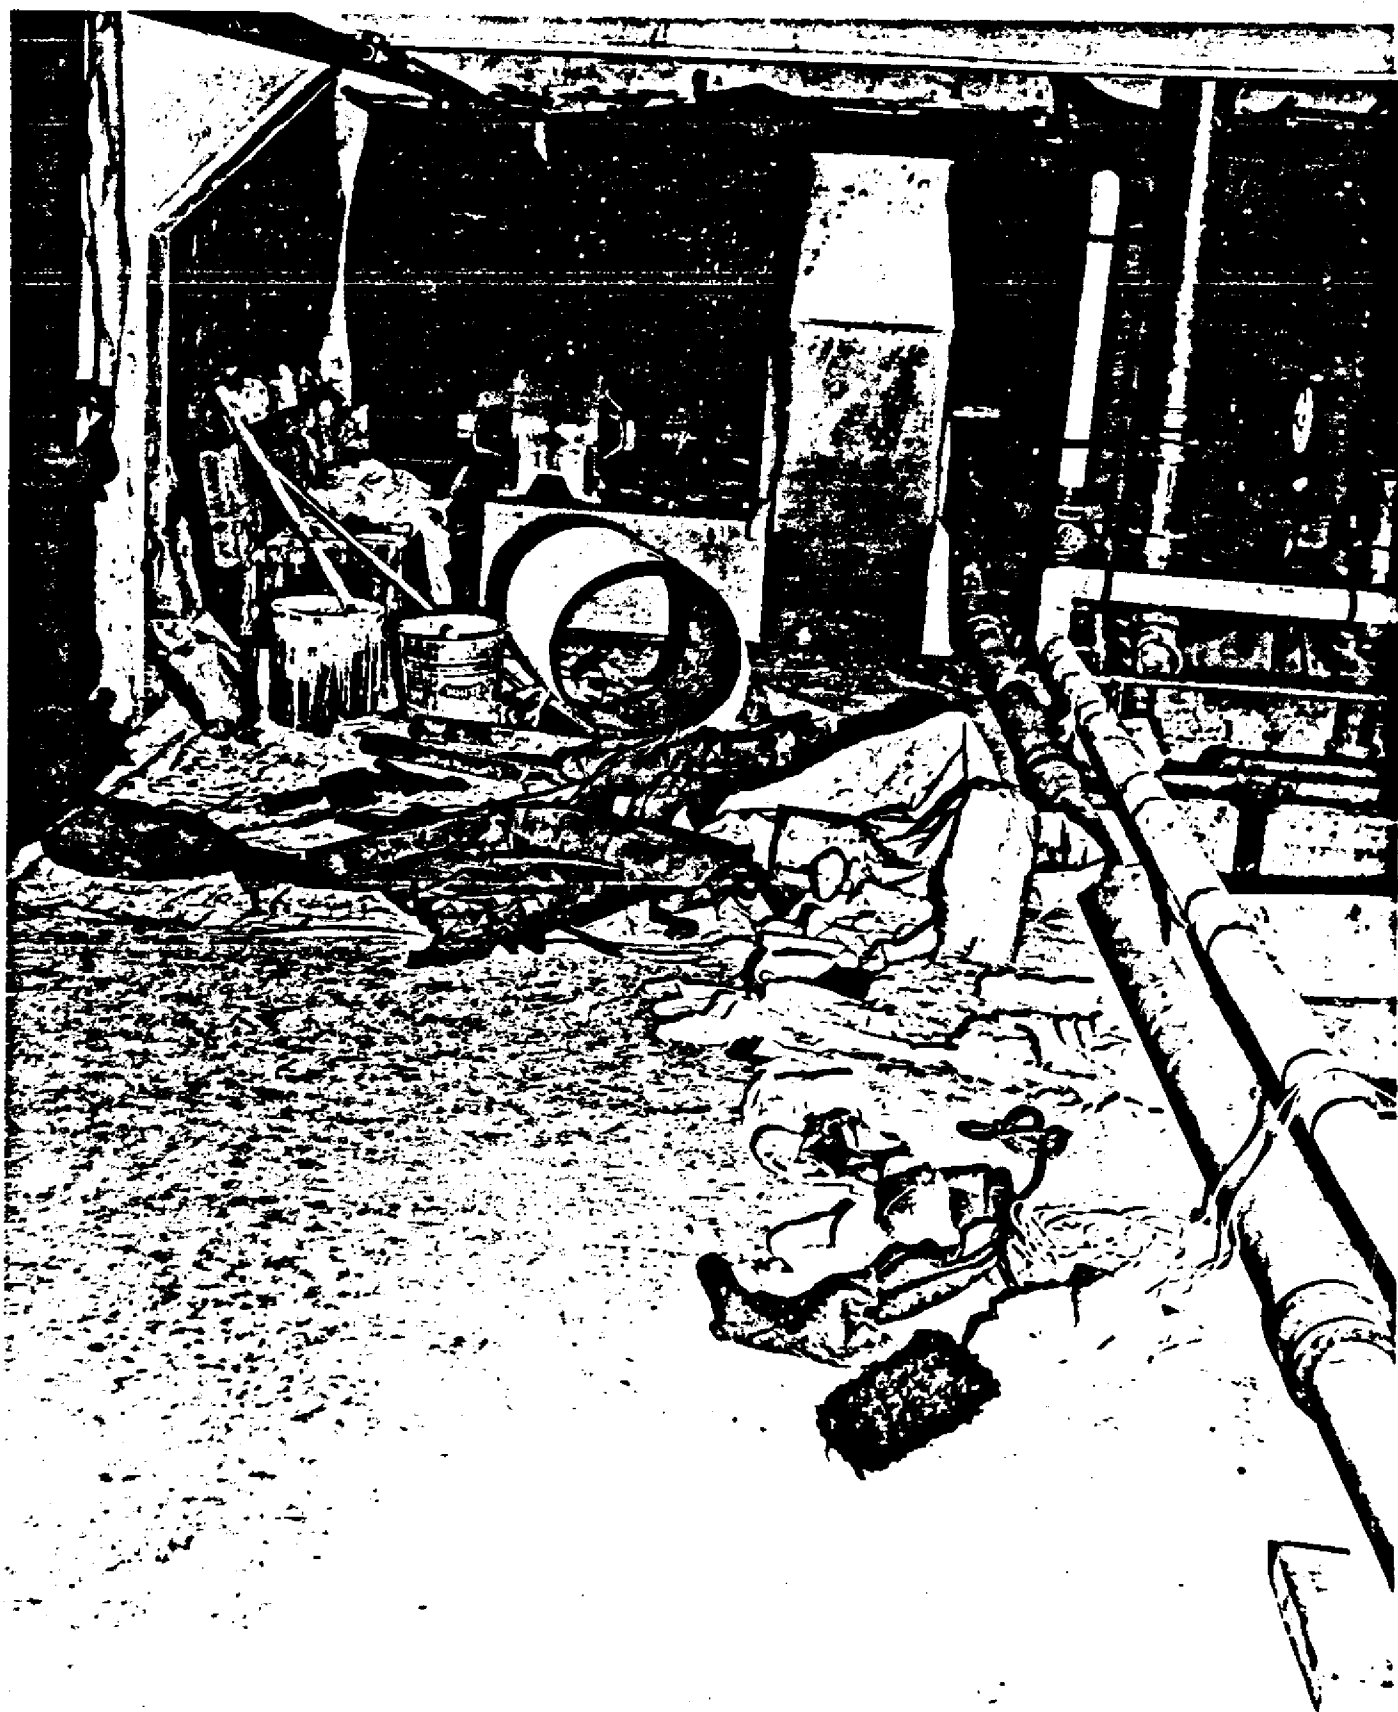
3-11 A general view looking toward the end of Cell Block B. The portion of the blanketed grill wall seen across the upper portion of the picture was across the end of the cell block. Approximately directly opposite the large black cast iron vent seen in upper right and down on the main floor was the main entrance to the entire cell area. The blanketed or screened-in area covered an area approximately thirty to thirty-five feet in length from the end of the cell block and extending on both sides, giving perfect concealment.

At lower right center may be seen a white cord which was tied to the hot water pipe crossing between Cell Block B and C and was one inch in diameter. This cord was lowered down the utility shaft and upon reaching the bottom, which was directly behind Subject's cells, it was determined to be twenty-six feet ten inches. Sections of this cord were knotted at intervals which apparently indicated the tier level reached when lowering or raising the rope. Fragments of raincoat material may be observed in general debris in center of picture. The five-gallon paint bucket from which a stick is seen protruding contained hardened cement paint and it was in this bucket a number of the Subjects' tools were subsequently located.

The heavy plank extending across the chair may have been used as the weight necessary when "vulcanizing" the seams on the raft and "Mae West" jacket.
