SUBJECT: TWA FLIGHT 800

FORENSIC ANALYSIS

Title: UNSUBS;
EXPLOSION OF FLIGHT TWA 800;
AOT-IT;
EOD; OO: NY

Synopsis: Outstanding FBI HQ Laboratory Reports

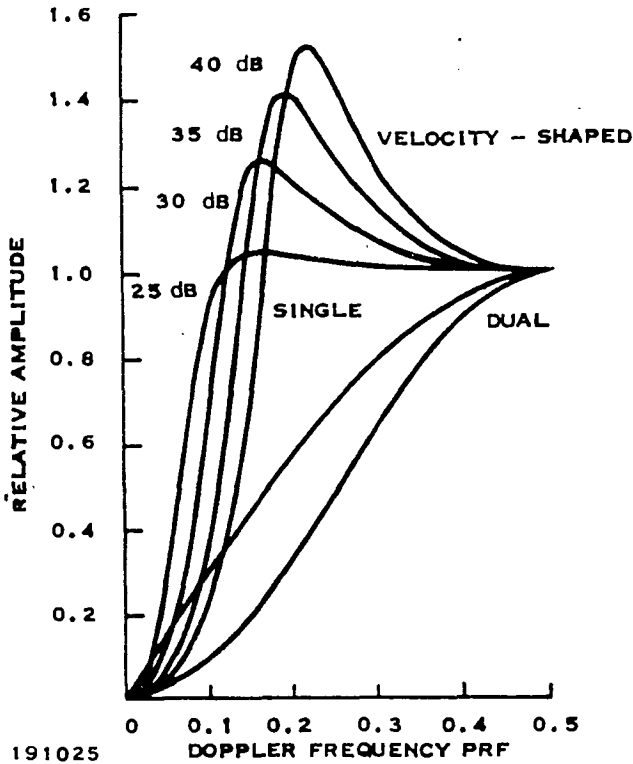
Figure 3-24. MTI Canceller Response Curves

These four response curves, in addition to the half-sine and sine-squared response of the single and dual cancellers, respectively, are shown in Figure 3-24. The feedback curves shown result in 25, 30, 35, and 40 dB of cancellation on clutter caused by antenna scanning. These curves offer progressively better clutter cancellation with reduced target response at low velocity. Performance is not subject to drift or change in characteristic since the multiplication is performed by hardwired digital logic circuitry. However, the response curves can be displayed on an oscilloscope using the built-in swept-frequency generator to confirm that no failures have occurred in the canceller circuitry.
