SUBJECT John Anglin, Clarence Anglin and
Frank Lee Morris Escape from Alcatraz

FILE NUMBER 76-26295

VOLUME NUMBER Enclosures 76, 137, 155 and 179

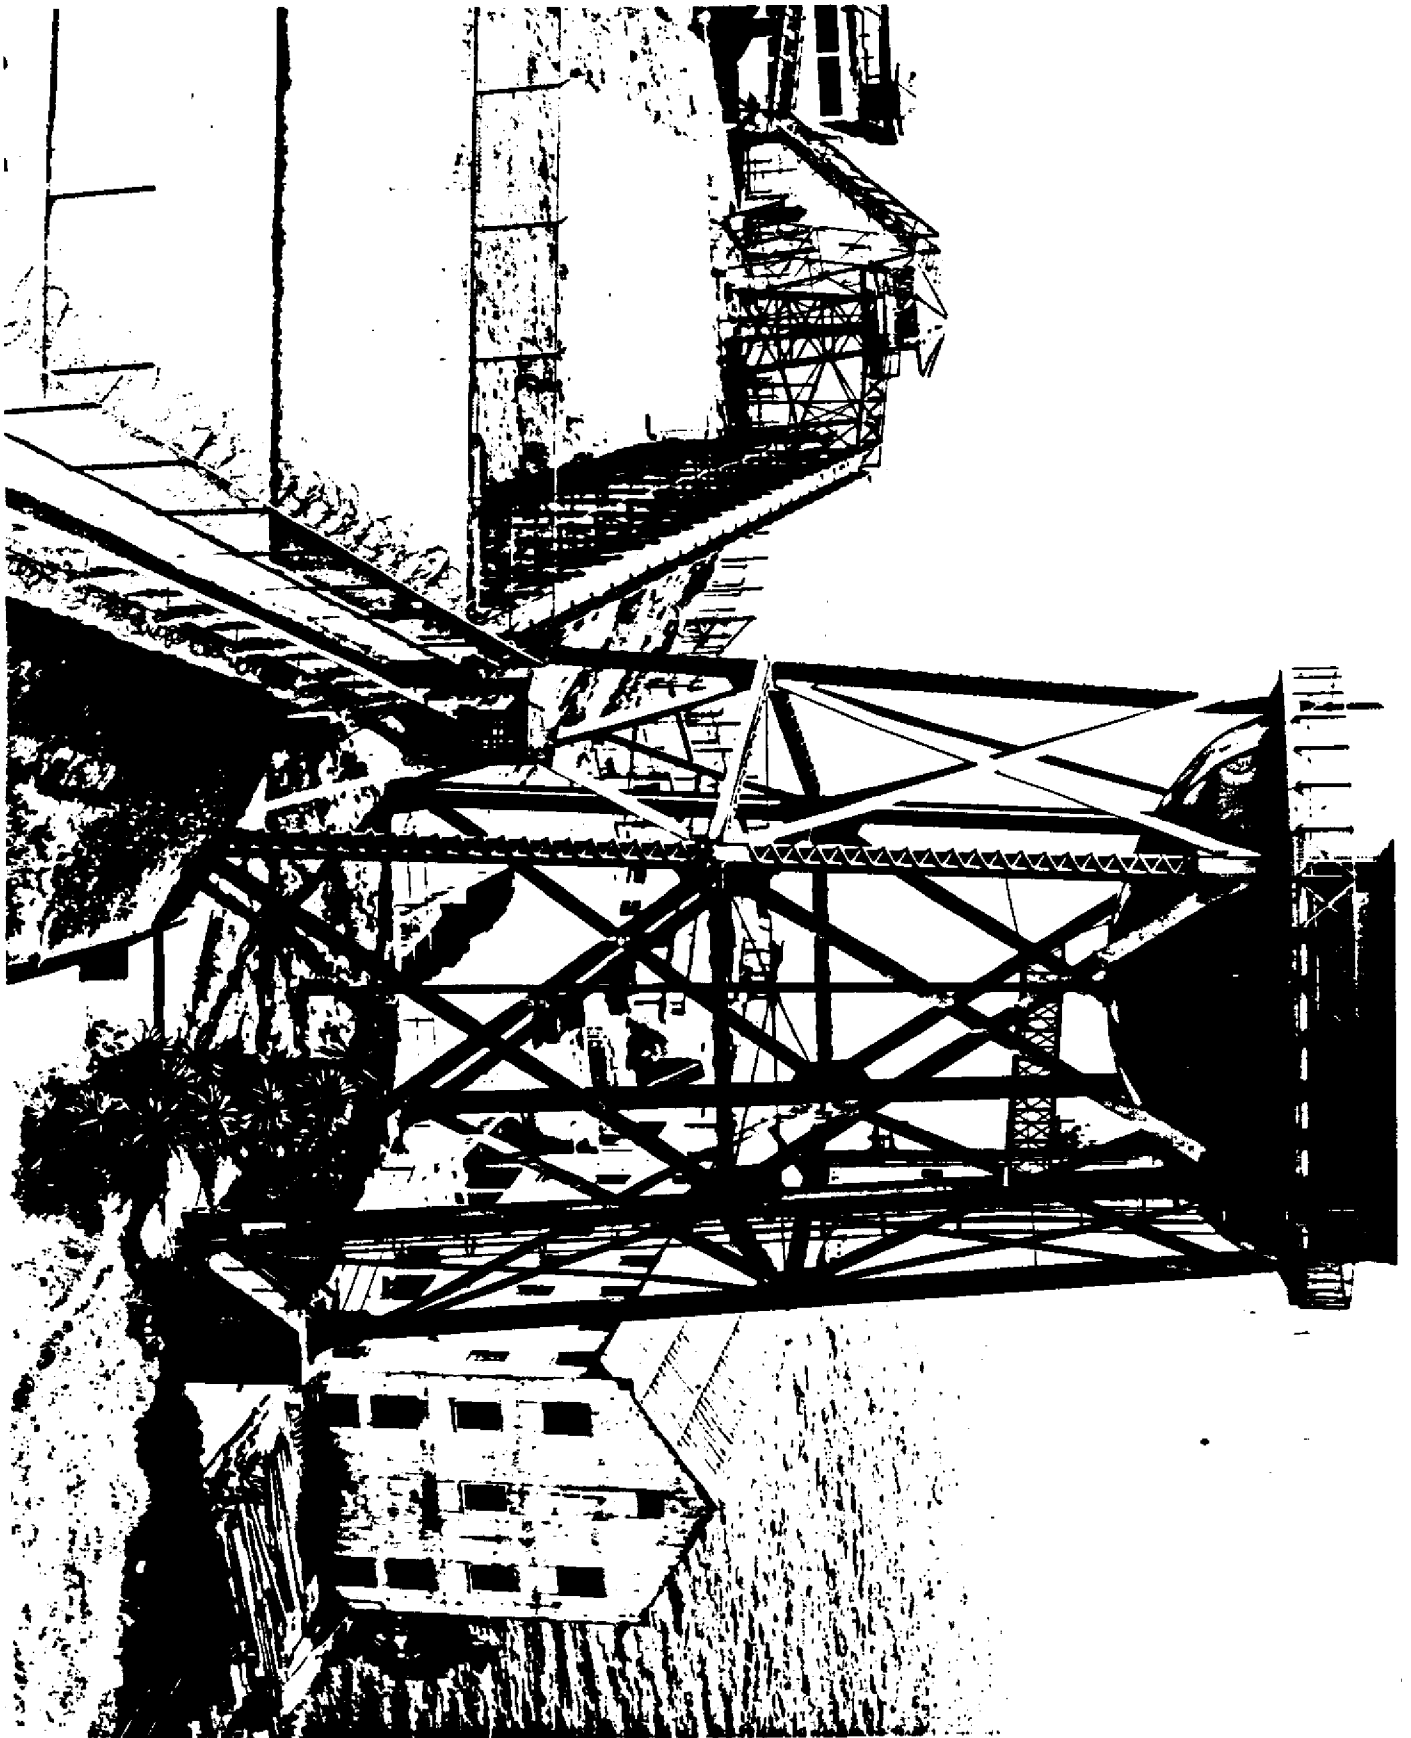
2-3 Same general view as 2-2 except that a larger portion of the recreation area is visible.

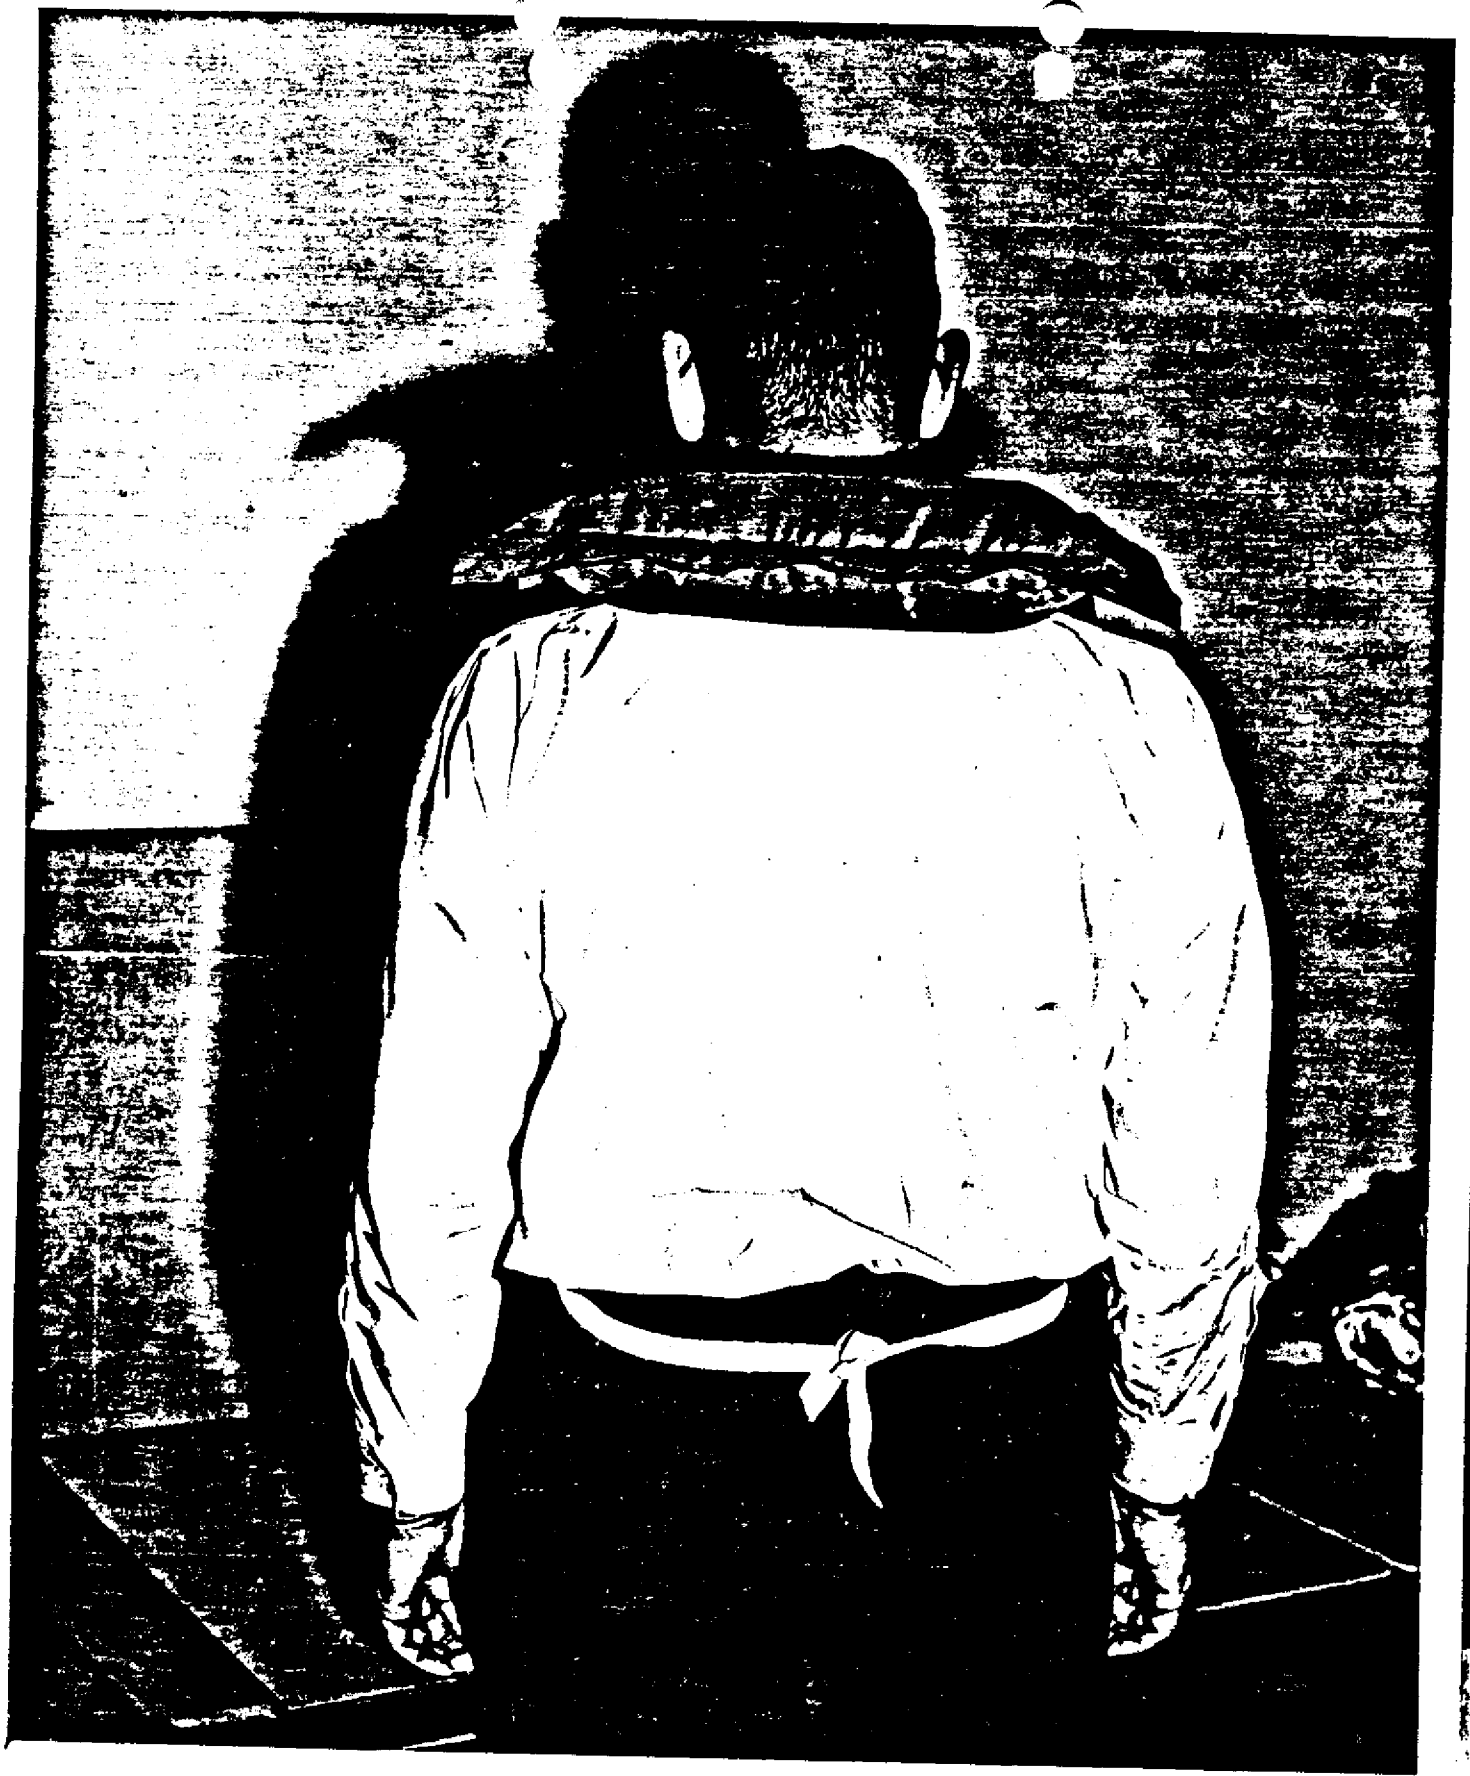
Front view of yoke type vest being worn by Special Agent.
(Photo by SA [REDACTED] 6/14/62)
